LZ BLACKBIRD

GRID: 775687

TA: 9B

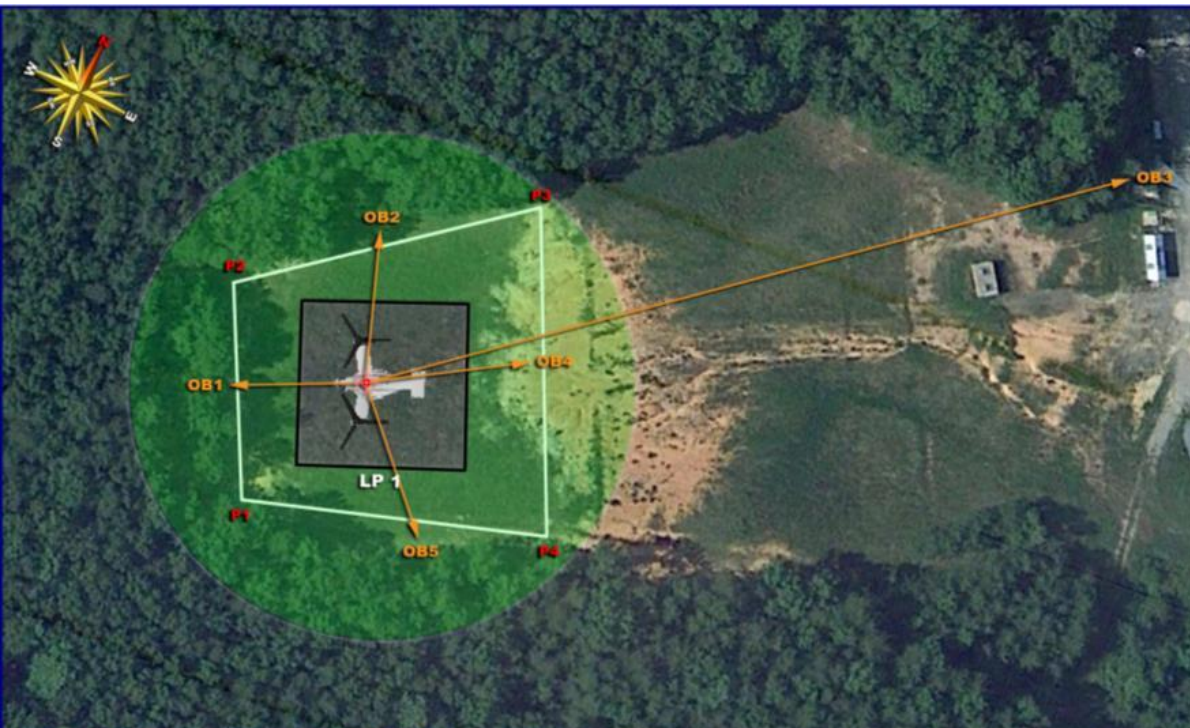
1. Current conditions consist of uneven terrain, loose dirt, gravel, and grass up to 0.9 m (3.0 ft) tall throughout LZ.					
2. LZ sits up on a hill west of a range.

3. Large trees line the north, south, and west perimeter of the LZ.					
4. Evidence of severe water runoff damage exists along the eastern perimeter and is starting to encroach into the LZ perimeter.

5. The five houses located throughout the LZ should be relocated closer to the perimeters to provide the proper safety clearances.					
6. A large radio antenna tower is located approximately 150.9 m (495.0 ft) east of LZ center and should be considered when determining approach and departure patterns.

7. Facility planners should coordinate with local command to determine utilization of LZ and size and/or improve LZ surface appropriately.					
Obstacle (OB) Location					
OB to LP	Type	Distance m (ft)	Height m (ft)	Width m (ft)	Depth m (ft)
OB1	Tree Line	27.4 (90.0)	19.3 (63.0)	99.0 (325.0)	
OB2	Tree Line	29.0 (95.0)	18.3 (60.0)	194.6 (640.0)	
OB3	Radio Tower	154.9 (495.0)	45.7 (150.0)		
OB4	Drop Off	30.6 (100.0)	7.6 (25.0)	67.1 (220.0)	
OB5	Tree Line	27.0 (89.0)	18.3 (60.0)	144.6 (474.0)	
Landing Point (LP) Location					
Location	Latitude	Longitude	Location	Latitude	Longitude
LP1	38° 32' 19.87" N	77° 33' 9.70" W
