# LZ CHICKEN

GRID: 807716

TA: 10A

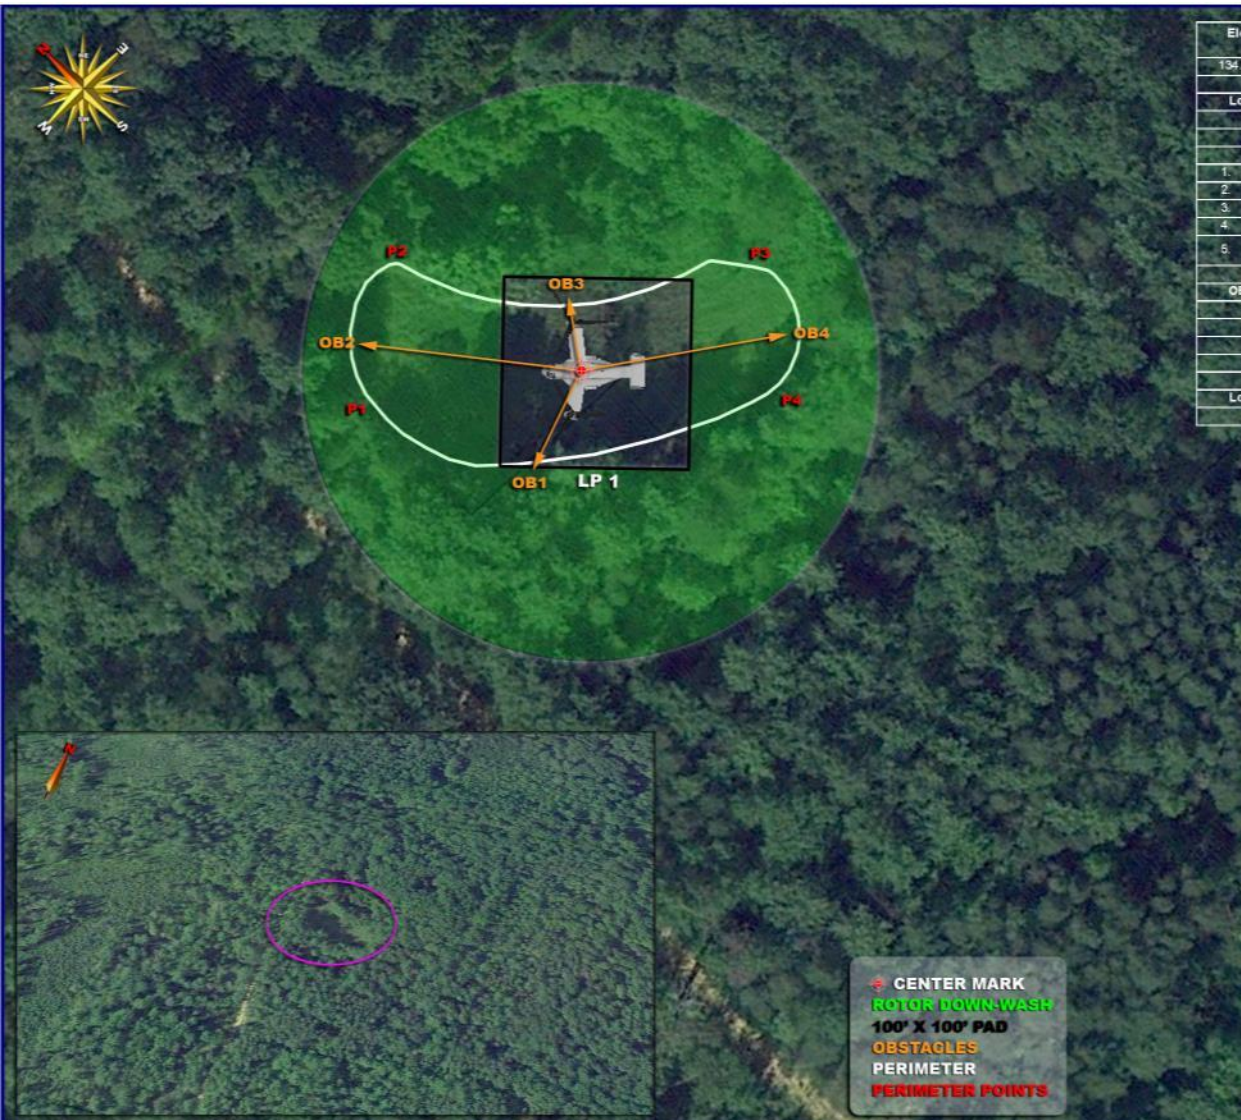
Elevation ft. (ft)	LZ Chicken Center		Slope Degrees	Slope Direction High to Low	Evaluation Adequate/Substandard/Inadequate
	Latitude	Longitude			
134.1 (440.0)	38°33'58.70"N	77°31'1.84"W	≤ 1.0	N/A	Inadequate
Perimeter (P) Location					
Location	Latitude	Longitude	Location	Latitude	Longitude
P1	38°33'58.36"N	77°31'2.47"W	P3	38°33'57.41"N	77°30'59.86"W
P2	38°33'58.81"N	77°31'1.67"W	P4	38°33'56.88"N	77°31'0.40"W
Remarks

1.	Surface conditions consist of uneven terrain, loose dirt and grass up to 1.8 m (6.0 ft) tall throughout LZ.				
2.	LZ is severely overgrown and has several dead trees and limb that a fallen within the perimeter.

3.	Large trees line the entire perimeter of the LZ.				
4.	Area is not suitable to support MV-22 operations.				
6.	Facility planners should coordinate with local command to determine utilization of LZ and size and/or improve LZ surface appropriately.				
Obstacle (OB) Location					
OB to LP	Type	Distance m (ft)	Height m (ft)	Width m (ft)	Depth m (ft)
OB1	Tree Line	13.7 (450.0)	18.3 (60.0)	76.2 (250.0)	
OB2	Tree Line	36.6 (120.0)	18.3 (60.0)	19.8 (65.0)	
OB3	Tree Line	13.7 (450.0)	18.3 (60.0)	76.2 (250.0)	
OB4	Tree Line	36.6 (120.0)	18.3 (60.0)	24.4 (80.0)	
Landing Point (LP) Location					
Location	Latitude	Longitude	Location	Latitude	Longitude
LP1	38°33'58.70"N	77°31'1.84"W
