# LZ CROW

GRID: 884741

TA: 16G

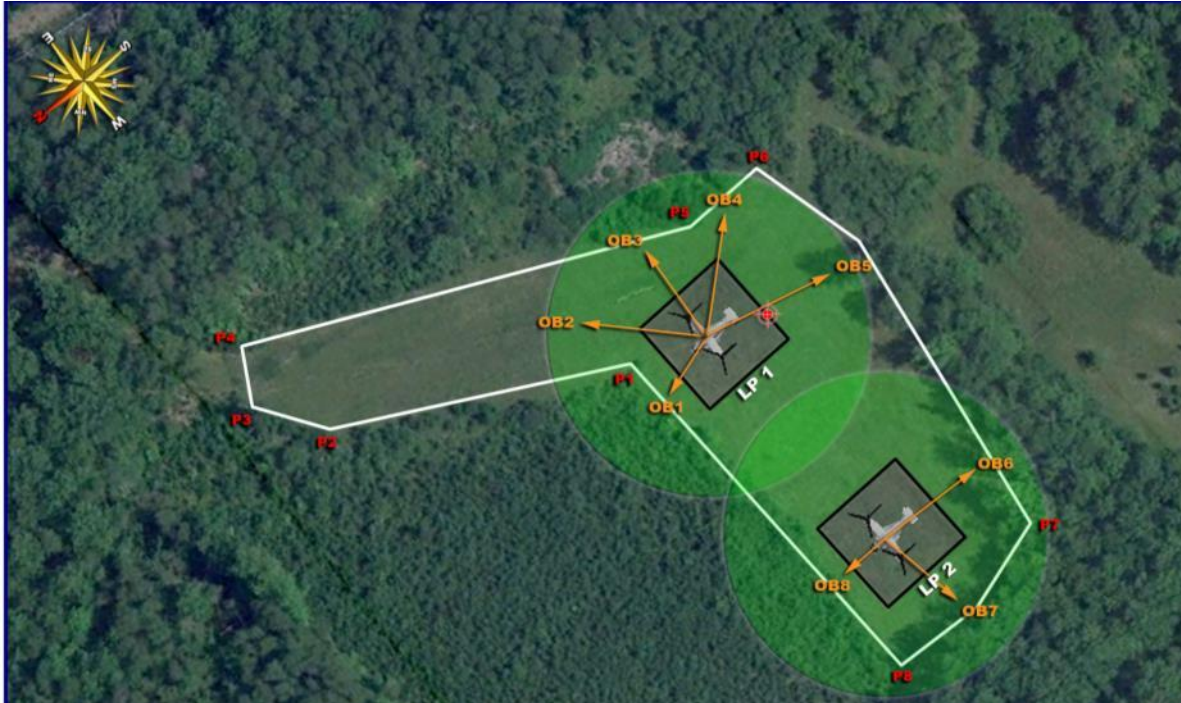
1.	Surface conditions consist of uneven terrain, loose dirt and grass up to 1.2 m (4.0 ft) tall throughout LZ.				
2.	A trench located in the center of the northeast portion of the LZ runs north and south making it inadequate to support MV-22 operations.

3.	The southwest portion of the LZ is prone to flooding during high periods of rain.				
4.	The LZ is surrounded by trees that vary from 7.6 m (25.0 ft) to 18.3 m (60.0 ft) tall.

5.	Facility planners should coordinate with local command to determine utilization of LZ and size and/or improve LZ surface appropriately.				
Obstacle (OB) Location					
OB to LP	Type	Distance m (ft)	Height m (ft)	Width m (ft)	Depth m (ft)
OB1-(LP1)	Tree Line	21.3 (70.0)	7.6 (25.0)	115.8 (380.0)	
OB2-(LP1)	Trench	27.4 (90.0)	0.8 (3.0)	173.7 (570.0)	1.2 (4.0)
OB3-(LP1)	Tree Line	36.8 (120.0)	7.6 (25.0)	137.2 (450.0)	
OB4-(LP1)	Tree Line	36.8 (120.0)	7.6 (25.0)	33.5 (110.0)	
OB5-(LP1)	Tree Line	41.1 (135.0)	18.3 (60.0)	118.9 (390.0)	
OB6-(LP2)	Tree Line	29.0 (95.0)	18.3 (60.0)	118.9 (390.0)	
OB7-(LP2)	Tree Line	29.0 (95.0)	18.3 (60.0)	51.8 (170.0)	
OB8-(LP2)	Tree Line	19.8 (65.0)	7.6 (25.0)	115.8 (380.0)	
Landing Point (LP) Location					
Location	Latitude	Longitude	Location	Latitude	Longitude
LP1	38°35'28.21"N	77°25'42.93"W	LP2	38°35'28.15"N	77°25'46.31"W
