# LZ FINCH

GRID: 864753

TA: 16F

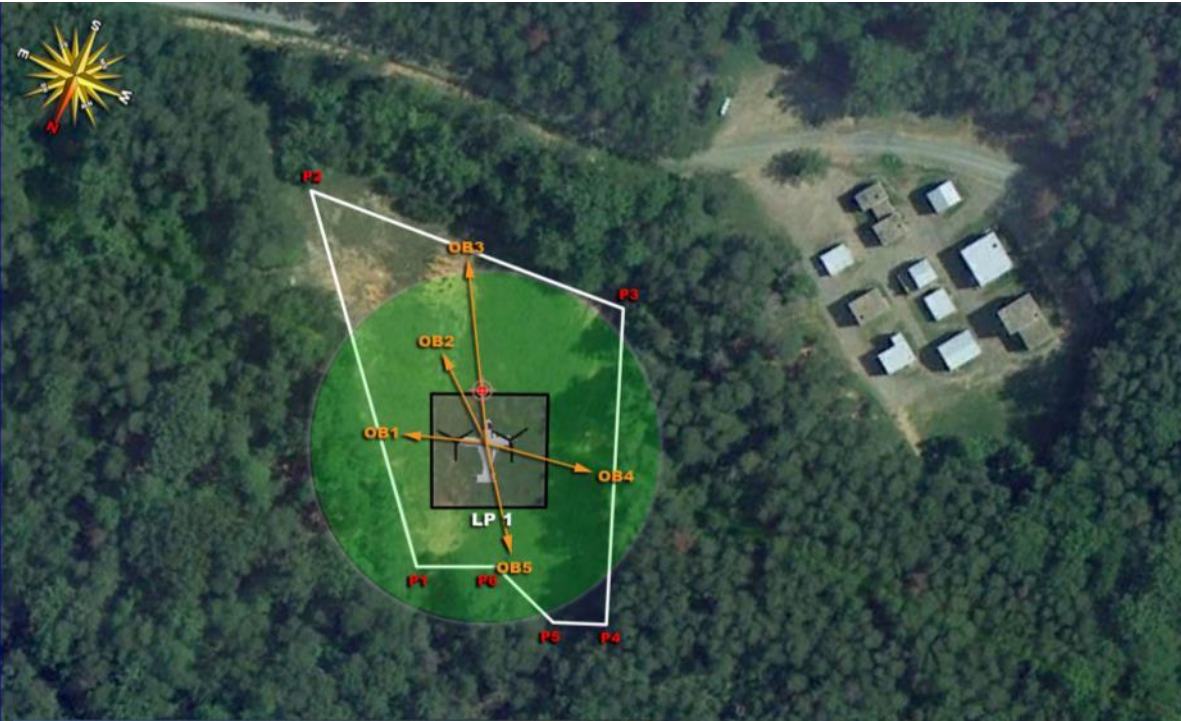
1.	Surface conditions consist of uneven terrain, loose dirt, and grass up to 0.5 m (1.5 ft) tall throughout the LZ.				
2.	The LZ appeared to have just been cleared/moved leaving behind small tree stumps which could puncture the aircraft tires.

3.	The northern portion of the LZ has a slope of 6.0 degrees from the outer perimeter to the center (north to south) while the southern portion of LZ has a slope of 11.0 degrees from the outer perimeter to the center (south to north) causing a bowl like affect in the center of the LZ.

4.	Large trees line the entire perimeter of the LZ.				
6.	Facility planners should coordinate with local command to determine utilization of LZ and size and/or improve LZ surface appropriately.				
Obstacle (OB) Location					
OB to LP	Type	Distance m (ft)	Height m (ft)	Width m (ft)	Depth m (ft)
OB1	Tree Line	30.5 (100.0)	18.3 (60.0)	168.7 (350.0)	
OB2	Elevated Area	25.9 (85.0)	3.0 (10.0)	56.4 (185.0)	
OB3	Tree Line	50.3 (165.0)	18.3 (60.0)	96.0 (315.0)	
OB4	Tree Line	32.0 (105.0)	18.3 (60.0)	99.1 (325.0)	
OB5	Tree Line	24.4 (80.0)	18.3 (60.0)	50.3 (165.0)	
Landing Point (LP) Location					
Location	Latitude	Longitude	Location	Latitude	Longitude
LP1	38°36'1.78"N	77°27'9.94"W
