# LZ GULL

GRID: 883655

TA: 5A

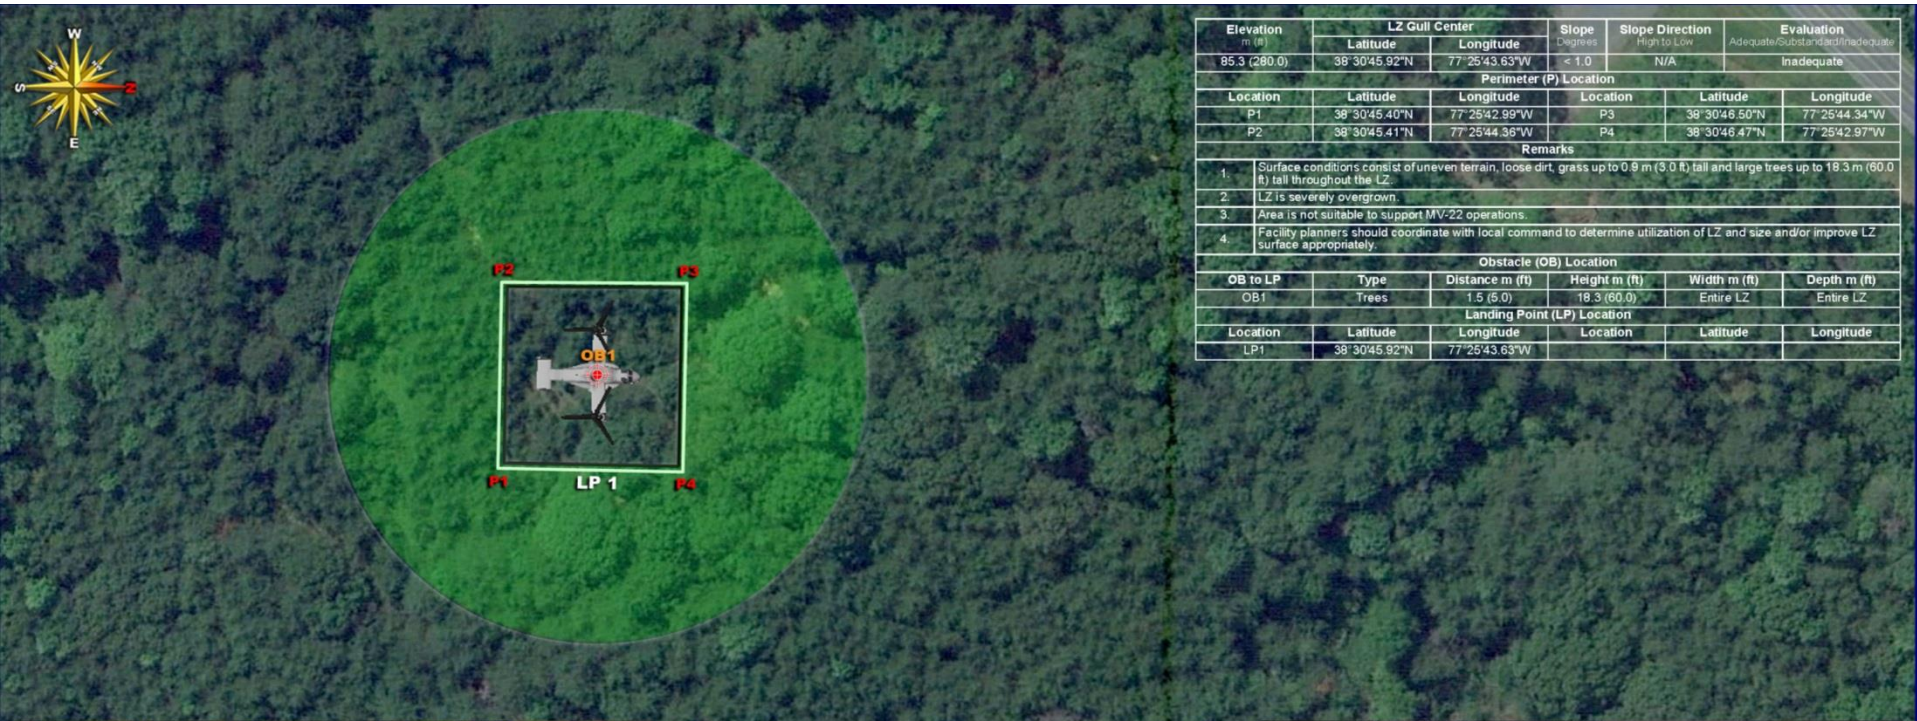
1.	Surface conditions consist of uneven terrain, loose dirt, grass up to 0.9 m (3.0 ft) tall and large trees up to 18.3 m (60.0 ft) tall throughout the LZ.

2.	LZ is severely overgrown.				
3.	Area is not suitable to support MV-22 operations.				
4.	Facility planners should coordinate with local command to determine utilization of LZ and size and/or improve LZ surface appropriately.				
Obstacle (OB) Location					
OB to LP	Type	Distance m (ft)	Height m (ft)	Width m (ft)	Depth m (ft)
OB1	Trees	1.5 (5.0)	18.3 (60.0)	Entire LZ	Entire LZ
Landing Point (LP) Location					
Location	Latitude	Longitude	Location	Latitude	Longitude
LP1	38° 30'45.92"N	77° 25'43.63"W
