# LZ MARTIN

GRID: 874766

TA: 16C

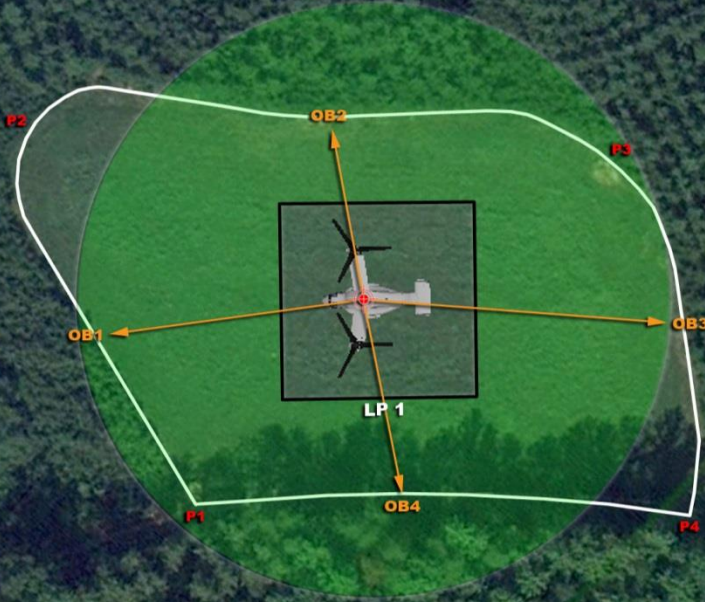
Elevation m (ft)	LZ Martin Center		Slope Degrees	Slope Direction High to Low	Evaluation Adequate/Substandard/Inadequate
	Latitude	Longitude			
89.9 (295.0)	38°36'44.64"N	77°26'28.63"W	< 1.0	N/A	Substandard
Perimeter (P) Location					
Location	Latitude	Longitude	Location	Latitude	Longitude
P1	38°36'44.98"N	77°26'30.54"W	P3	38°36'44.75"N	77°26'26.95"W
P2	38°36'46.02"N	77°26'29.49"W	P4	38°36'42.97"N	77°26'28.09"W
Remarks

1.	Surface conditions consist of loose dirt and grass up to 0.9 m (3.0 ft) tall throughout the LZ.				
2.	Large trees line the entire perimeter of the LZ.

3.	Facility planners should coordinate with local command to determine utilization of LZ and size and/or improve LZ surface appropriately.				
Obstacle (OB) Location					
OB to LP	Type	Distance m (ft)	Height m (ft)	Width m (ft)	Depth m (ft)
OB1	Tree Line	42.7 (140.0)	7.6 (25.0)	70.1 (230.0)	
OB2	Tree Line	29.0 (95.0)	7.6 (25.0)	84.5 (310.0)	
OB3	Tree Line	45.7 (150.0)	7.6 (25.0)	73.2 (240.0)	
OB4	Tree Line	32.0 (105.0)	18.3 (60.0)	88.4 (290.0)	
Landing Point (LP) Location					
Location	Latitude	Longitude	Location	Latitude	Longitude
LP1	38°36'44.64"N	77°26'28.63"W
