# LZ ORIOLE

GRID: 880730

TA: 12B

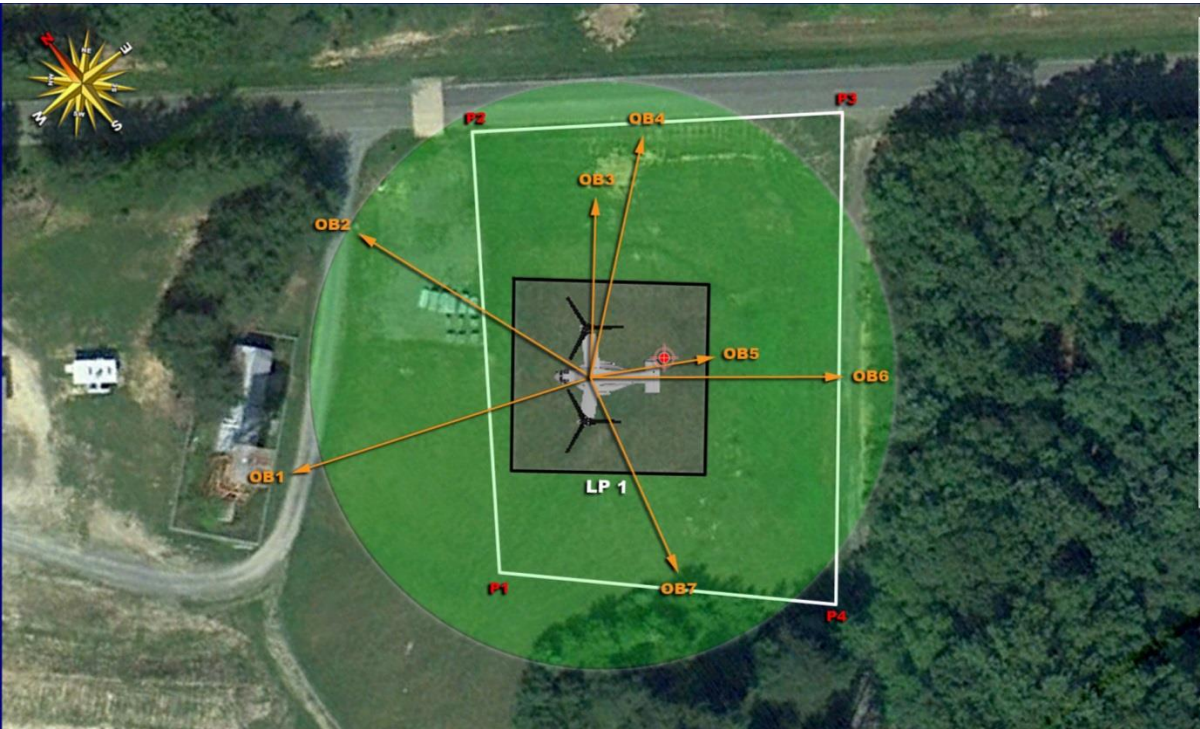
Elevation m (ft)	LZ Oriole Center		Slope Degrees	Slope Direction High to Low	Evaluation Adequate/Standard/Inadequate
	Latitude	Longitude			
114.3 (375.0)	38°34'50.31"N	77°26'1.03"W	6.5	West to East	Substandard
Perimeter (P) Location					
Location	Latitude	Longitude	Location	Latitude	Longitude
P1	38°34'49.85"N	77°26'2.85"W	P3	38°34'50.79"N	77°25'58.95"W
P2	38°34'51.82"N	77°26'1.07"W	P4	38°34'48.70"N	77°26'0.90"W
Remarks

1.	Surface conditions consist of uneven terrain, loose dirt and grass up to 0.6 m (2.0 ft) tall throughout the LZ.				
2.	Large trees line the both the southeast and southwest perimeters.

3.	A large pile of metal construction material is located on the northwest perimeter near the center of the LZ.				
4.	Several holes/ditches located in the southeastern portion of the LZ not allowing the initial 19.8 m (65.0 ft) of the LZ unusable.

5.	The road that runs the length of the northeast perimeter is elevated above the LZ approximately 2.4 m (8.0 ft).				
6.	Facility planners should coordinate with local command to determine utilization of LZ and size and/or improve LZ surface appropriately.				
Obstacle (OB) Location					
OB to LP	Type	Distance m (ft)	Height m (ft)	Width m (ft)	Depth m (ft)
OB1	Range Tower	54.9 (180.0)	18.3 (60.0)	6.1 (20.0)	6.1 (20.0)
OB2	Tree Line	47.5 (155.0)	12.2 (40.0)	45.7 (150.0)	
OB3	Post	32.0 (105.0)	1.8 (6.0)		
OB4	Hill/Road	42.7 (140.0)	2.4 (8.0)	76.2 (250.0)	
OB5	Holes/Ditches	21.3 (70.0)	0.6 (2.0)	88.6 (225.0)	19.8 (65.0)
OB6	Tree Line	42.7 (140.0)	12.2 (40.0)	76.2 (250.0)	
OB7	Tree Line	32.0 (105.0)	18.3 (60.0)	60.3 (195.0)	
Landing Point (LP) Location					
Location	Latitude	Longitude	Location	Latitude	Longitude
LP1	38°34'50.39"N	77°26'1.36"W
