LZ REDBIRD

GRID: 791664

TA: 9B

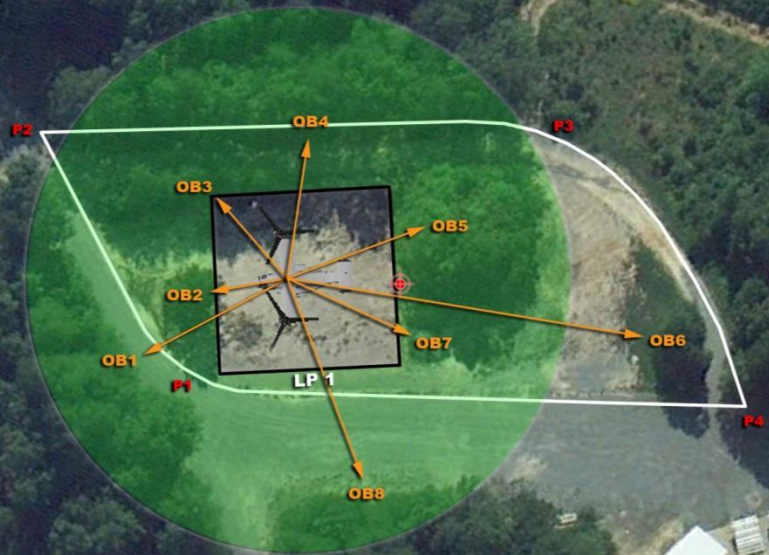
1.	Surface conditions consist of loose dirt, gravel, rocks up to 0.5 m (1.5 ft) in diameter, grass up to 0.3 m (1.0 ft) tall and large trees up to 9.1 m (30.0 ft) tall throughout the LZ.

2.	Large trees line the entire perimeter of the LZ.				
3.	There is a large pile of debris located at the center of the east perimeter of the LZ and should be removed to provide the proper safety clearances.

4.	Facility planners should coordinate with local command to determine utilization of LZ and size and/or improve LZ surface appropriately.				
Obstacle (OB) Location					
OB to LP	Type	Distance m (ft)	Height m (ft)	Width m (ft)	Depth m (ft)
OB1	Tree Line	30.5 (100.0)	18.3 (60.0)	71.6 (235.0)	
OB2	Tree	12.2 (40.0)	9.1 (30.0)	9.1 (30.0)	9.1 (30.0)
OB3	Tree Line	19.8 (65.0)	9.1 (30.0)	35.1 (115.0)	6.1 (20.0)
OB4	Tree Line	22.9 (75.0)	18.3 (60.0)	82.3 (270.0)	
OB5	Tree	18.3 (60.0)	9.1 (30.0)	18.3 (60.0)	16.8 (55.0)
OB6	Tree	62.5 (205.0)	9.1 (30.0)	16.8 (55.0)	6.1 (20.0)
OB7	Pile of Debris	21.3 (70.0)	1.2 (4.0)	6.1 (20.0)	6.1 (20.0)
OB8	Tree Line	36.6 (120.0)	18.3 (60.0)	54.9 (180.0)	
Landing Point (LP) Location					
Location	Latitude	Longitude	Location	Latitude	Longitude
LP1	38°31'5.67"N	77°32'3.69"W
