# LZ SNIPE

GRID: 830764

TA: 16D

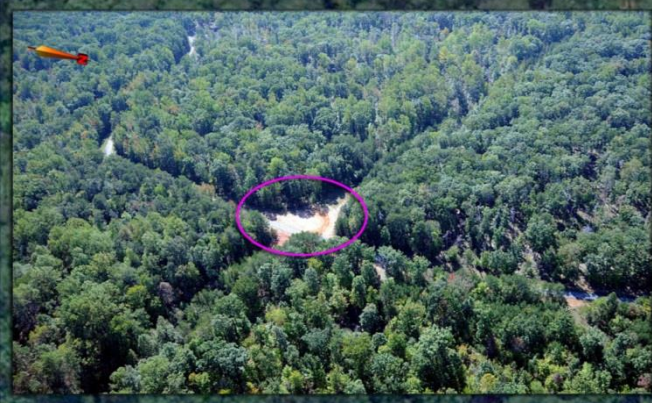
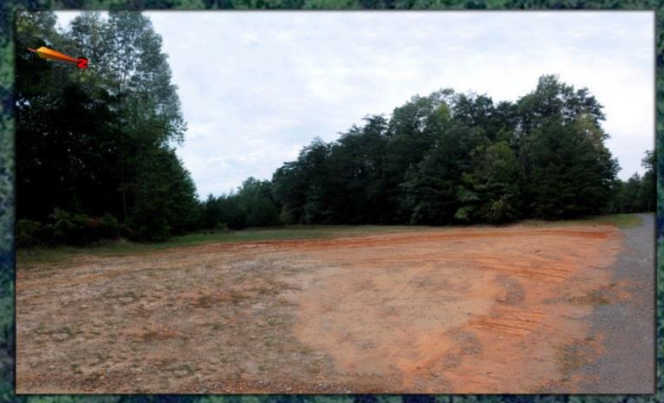
1. Surface conditions consist of loose dirt and gravel.					
2. Large trees line the entire perimeter of the LZ. A gravel access road also lines the eastern perimeter of the LZ.

3. Area is not suitable to support MV-22 operations.					
4. Facility planners should coordinate with local command to determine utilization of LZ and size and/or improve LZ surface appropriately.					
Obstacle (OB) Location					
OB to LP	Type	Distance m (ft)	Height m (ft)	Width m (ft)	Depth m (ft)
OB1	Tree Line	13.7 (45.0)	18.3 (60.0)	53.3 (175.0)	
OB2	Tree Line	32.0 (105.0)	9.1 (30.0)	18.3 (60.0)	
OB3	Tree Line	21.3 (70.0)	18.3 (60.0)	48.8 (160.0)	
OB4	Tree Line	53.3 (175.0)	18.3 (60.0)	59.4 (195.0)	
Landing Point (LP) Location					
Location	Latitude	Longitude	Location	Latitude	Longitude
LP1	38° 36' 35.91" N	77° 29' 34.27" W
