LZ SPARROW

GRID: 862751

TA: 16F

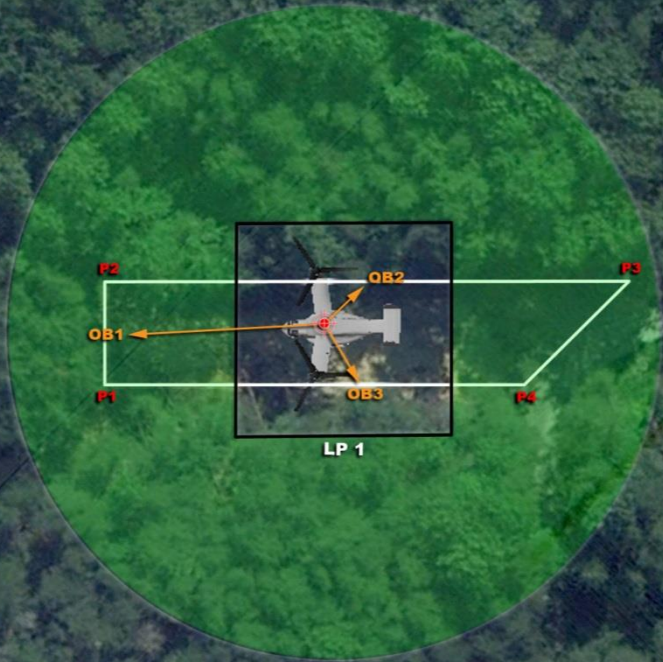
Elevation m (ft)	LZ Sparrow Center		Slope Degrees	Slope Direction High to Low	Evaluation Adequate/Substandard/Inadequate
	Latitude	Longitude			
104.5 (343.0)	38° 35'55.29"N	77° 27'18.94"W	< 1.0	N/A	Inadequate
Perimeter (P) Location					
Location	Latitude	Longitude	Location	Latitude	Longitude
P1	38° 35'54.47"N	77° 27'17.64"W	P3	38° 35'55.87"N	77° 27'20.31"W
P2	38° 35'54.12"N	77° 27'18.08"W	P4	38° 35'55.87"N	77° 27'19.40"W
Remarks

1.	Surface conditions consist of loose dirt, gravel and grass up to 0.3 m (1.0 ft) tall throughout the LZ.				
2.	Several dead trees and limbs have fallen within the perimeter.

3.	Area is not suitable to support MV-22 operations.				
4.	Facility planners should coordinate with local command to determine utilization of LZ and size and/or improve LZ surface appropriately.				
Obstacle (OB) Location					
OB to LP	Type	Distance m (ft)	Height m (ft)	Width m (ft)	Depth m (ft)
OB1	Tree Line	30.5 (100.0)	18.3 (60.0)	15.2 (50.0)	
OB2	Tree Line	7.6 (25.0)	18.3 (60.0)	73.2 (240.0)	
OB3	Tree Line	7.6 (25.0)	18.3 (60.0)	73.2 (240.0)	
Landing Point (LP) Location					
Location	Latitude	Longitude	Location	Latitude	Longitude
LP1	38° 35'55.29"N	77° 27'18.94"W
