# LZ TERN

GRID: 810759

TA: 15B

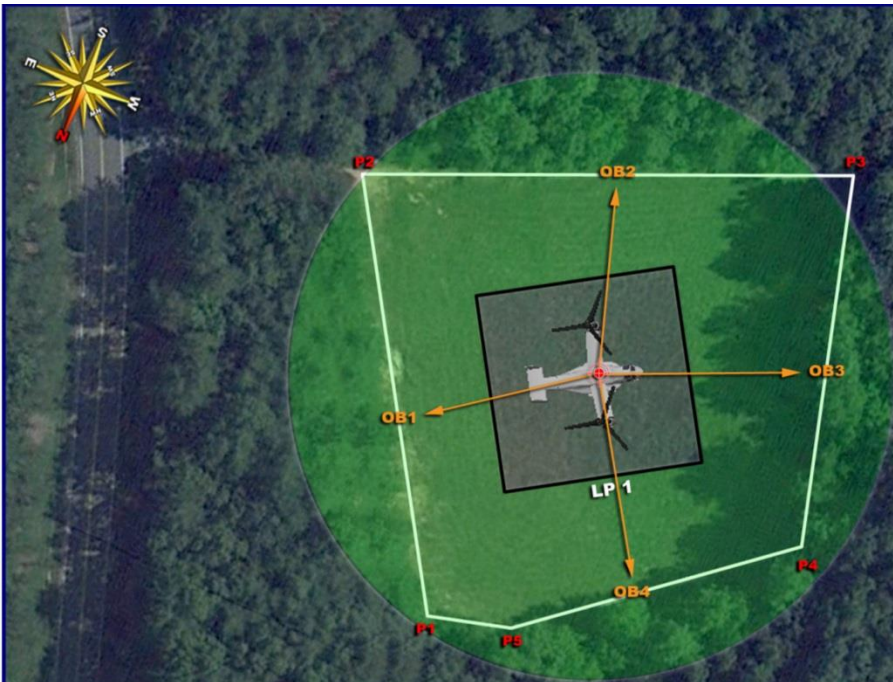
Elevation m (ft)	LZ Tern Center		Slope Degrees	Slope Direction High to Low	Evaluation Adequate/Substandard/Inadequate
	Latitude	Longitude			
74.8 (245.0)	38° 36' 17.34" N	77° 30' 53.16" W	Multiple	See Remarks	Substandard
Perimeter (P) Location					
Location	Latitude	Longitude	Location	Latitude	Longitude
P1	38° 36' 19.06" N	77° 30' 53.14" W	P4	38° 36' 17.98" N	77° 30' 55.17" W
P2	38° 36' 17.14" N	77° 30' 51.56" W	P5	38° 36' 18.83" N	77° 30' 53.63" W
P3	38° 36' 16.13" N	77° 30' 54.49" W			
Remarks

1.	Surface conditions consist of loose dirt and grass up to 0.3 m (1.0 ft) tall throughout the LZ.				
2.	The LZ slope < 2.0 degrees from center in all directions creating a bowl like affect in the center of the LZ causing potential flooding during periods of heavy rain.

3.	Large tree line the entire perimeter of the LZ.				
4.	Facility planners should coordinate with local command to determine utilization of LZ and size and/or improve LZ surface appropriately.				
Obstacle (OB) Location					
OB to LP	Type	Distance m (ft)	Height m (ft)	Width m (ft)	Depth m (ft)
OB1	Tree Line	32.0 (105.0)	18.3 (60.0)	68.6 (225.0)	
OB2	Tree Line	29.0 (95.0)	18.3 (60.0)	73.2 (240.0)	
OB3	Tree Line	32.0 (105.0)	18.3 (60.0)	57.9 (190.0)	
OB4	Tree Line	32.0 (105.0)	18.3 (60.0)	54.9 (180.0)	
Landing Point (LP) Location					
Location	Latitude	Longitude	Location	Latitude	Longitude
LP1	38° 36' 17.34" N	77° 30' 53.16" W
