LZ THRUSH

GRID: 889642

TA: 5C

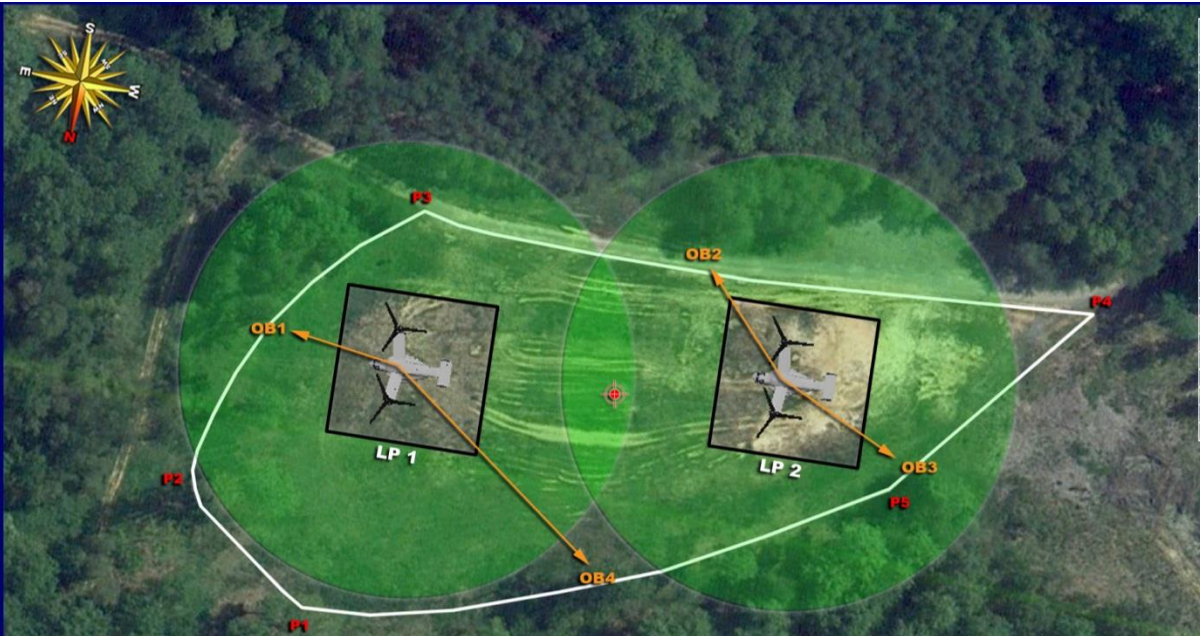
1. Surface conditions consist of loose dirt and grass up to 0.9 m (3.0 ft) tall throughout the LZ.					
2. Large trees line the entire perimeter of the LZ.

3. The LZ is severely rutted due to heavy vehicle traffic.					
4. The LZ drops off approximately 3.7 m (12.0 ft) at the northern perimeter.					
5. Facility planners should coordinate with local command to determine utilization of LZ and size and/or improve LZ surface appropriately.					
Obstacle (OB) Location					
OB to LP	Type	Distance m (ft)	Height m (ft)	Width m (ft)	Depth m (ft)
OB1-(LP1)	Tree Line	25.9 (85.0)	18.3 (60.0)	85.3 (280.0)	
OB2-(LP2)	Tree Line	30.5 (100.0)	18.3 (60.0)	152.4 (500.0)	
OB3-(LP2)	Tree Line	27.4 (90.0)	18.3 (60.0)	137.2 (450.0)	
OB4-(LP1)	Tree Line	54.9 (180.0)	18.3 (60.0)	137.2 (450.0)	
Landing Point (LP) Location					
Location	Latitude	Longitude	Location	Latitude	Longitude
LP1	38° 30' 4.22" N	77° 25' 12.08" W	LP2	38° 30' 3.74" N	77° 25' 15.38" W
