LZ ALBATROSS

GRID: 796767

TA: 17A

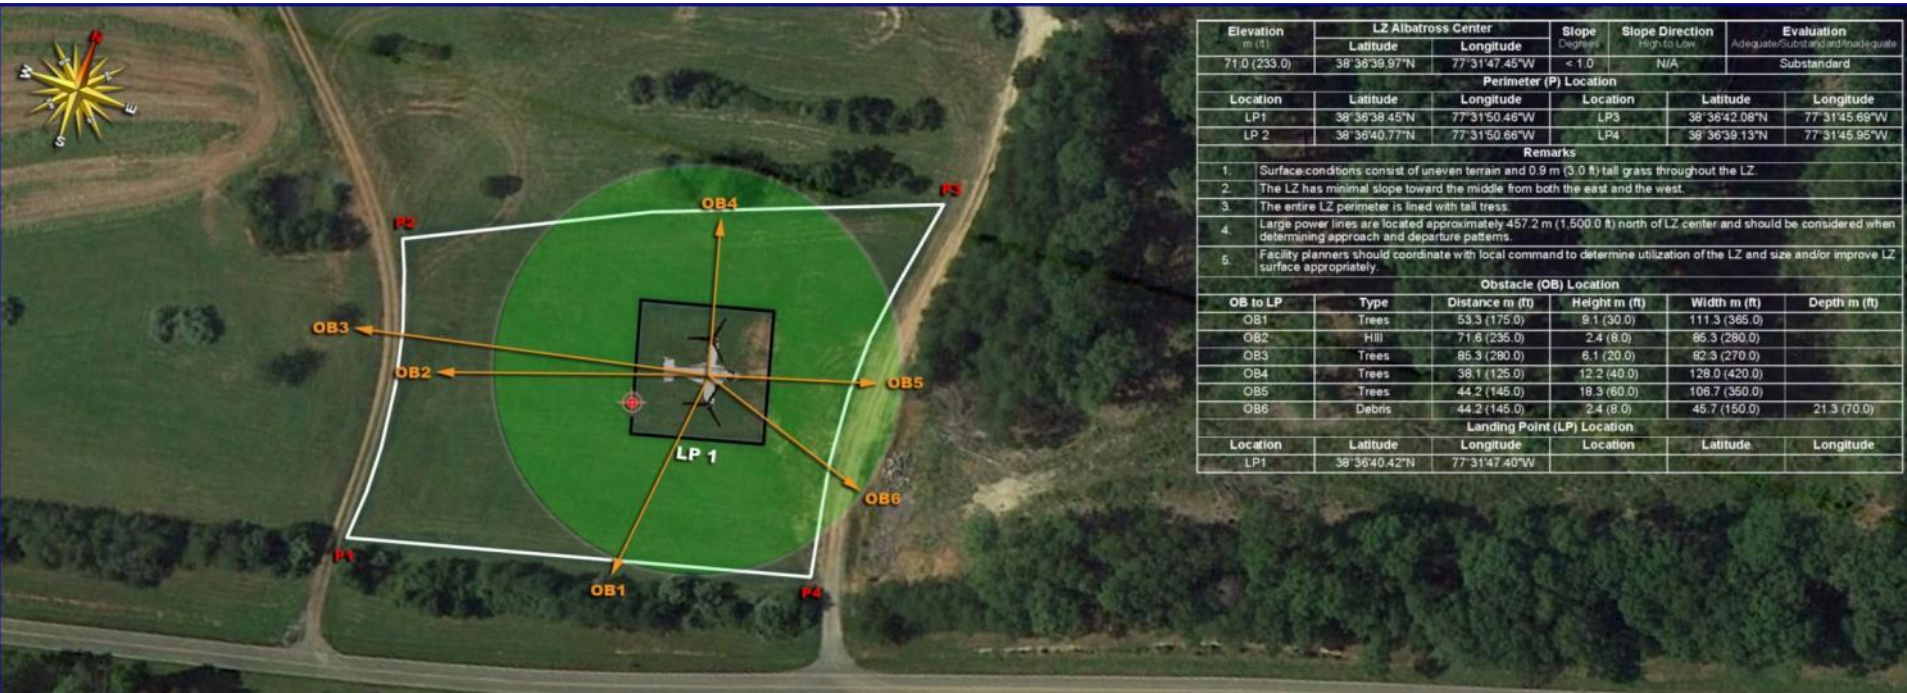
1. Surface conditions consist of uneven terrain and 0.9 m (3.0 ft) tall grass throughout the LZ.					
2. The LZ has minimal slope toward the middle from both the east and the west.

3. The entire LZ perimeter is lined with tall trees.					
4. Large power lines are located approximately 457.2 m (1,500.0 ft) north of LZ center and should be considered when determining approach and departure patterns.

5. Facility planners should coordinate with local command to determine utilization of the LZ and size and/or improve LZ surface appropriately.					
Obstacle (OB) Location					
OB to LP	Type	Distance m (ft)	Height m (ft)	Width m (ft)	Depth m (ft)
OB1	Trees	53.3 (175.0)	8.1 (30.0)	111.3 (365.0)	
OB2	Hill	71.6 (235.0)	2.4 (8.0)	85.3 (280.0)	
OB3	Trees	86.3 (280.0)	6.1 (20.0)	82.3 (270.0)	
OB4	Trees	38.1 (125.0)	12.2 (40.0)	128.0 (420.0)	
OB5	Trees	44.2 (145.0)	18.3 (60.0)	106.7 (350.0)	
OB6	Debris	44.2 (145.0)	2.4 (8.0)	45.7 (150.0)	21.3 (70.0)
Landing Point (LP) Location					
Location	Latitude	Longitude	Location	Latitude	Longitude
LP1	38° 36' 40.42" N	77° 31' 47.40" W
