# LZ BLUEBIRD

GRID: 864735

TA: 12A

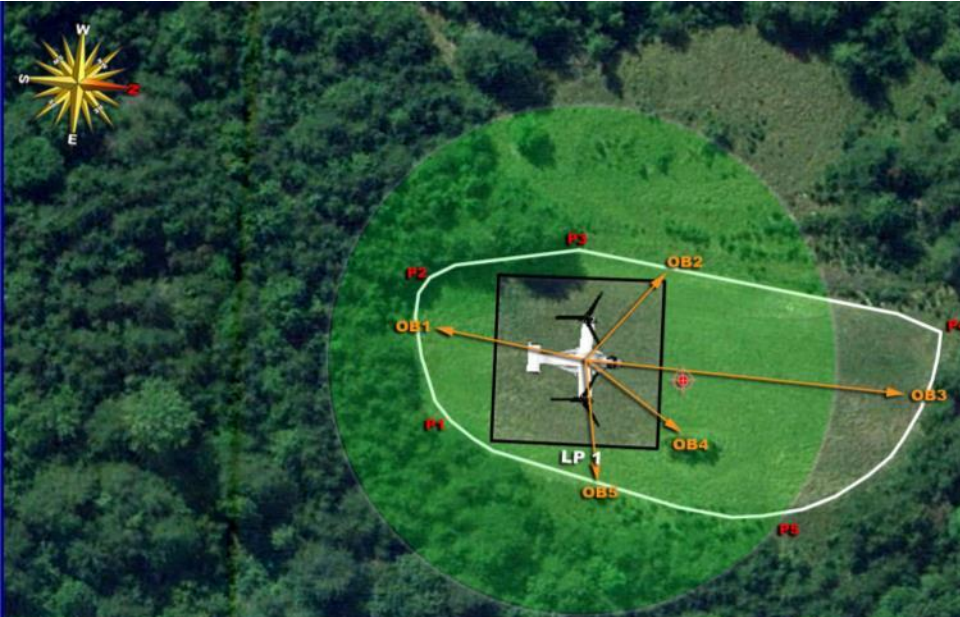
Elevation m (ft)	LZ Bluebird Center		Slope Degrees	Slope Direction High to Low	Evaluation	
	Latitude	Longitude			Adequate	Substandard/Inadequate
86.6 (284.0)	38°35'3.37"N	77°27'8.59"W	2.0	North to South		Substandard
Perimeter (P) Location						
Location	Latitude	Longitude	Location	Latitude	Longitude	
P1	38°35'2.14"N	77°27'7.94"W	P4	38°36'5.06"N	77°27'8.88"W	
P2	38°35'1.88"N	77°27'9.05"W	P5	38°36'3.73"N	77°27'7.36"W	
P3	38°35'2.60"N	77°27'9.39"W				
Remarks

1.	Surface conditions consist of dirt and grass up to 0.9 m (3.0 ft) tall throughout LZ.					
2.	Large trees line the entire perimeter of the LZ.					
3.	An old military tank is located near the center of the LZ.

4.	The bird houses located throughout the LZ should be relocated closer to the perimeters to provide the proper safety clearances.					
5.	Facility planners should coordinate with local command to determine utilization of LZ and size and/or improve LZ surface appropriately.					
Obstacle (OB) Location						
OB to LP	Type	Distance m (ft)	Height m (ft)	Width m (ft)	Depth m (ft)	
OB1	Tree Line	30.5 (100.0)	18.3 (60.0)	32.0 (105.0)		
OB2	Tree Line	24.4 (80.0)	18.3 (60.0)	99.1 (325.0)		
OB3	Tree Line	85.5 (215.0)	18.3 (60.0)	41.1 (135.0)		
OB4	Tank	22.9 (75.0)	3.7 (12.0)	7.6 (25.0)		3.7 (12.0)
OB5	Tree Line	30.5 (80.0)	18.3 (60.0)	99.1 (325.0)		
Landing Point (LP) Location						
Location	Latitude	Longitude	Location	Latitude	Longitude	
LP1	38°35'2.90"N	77°27'8.59"W
