# LZ BLUEJAY

GRID: 796720

TA: 14B

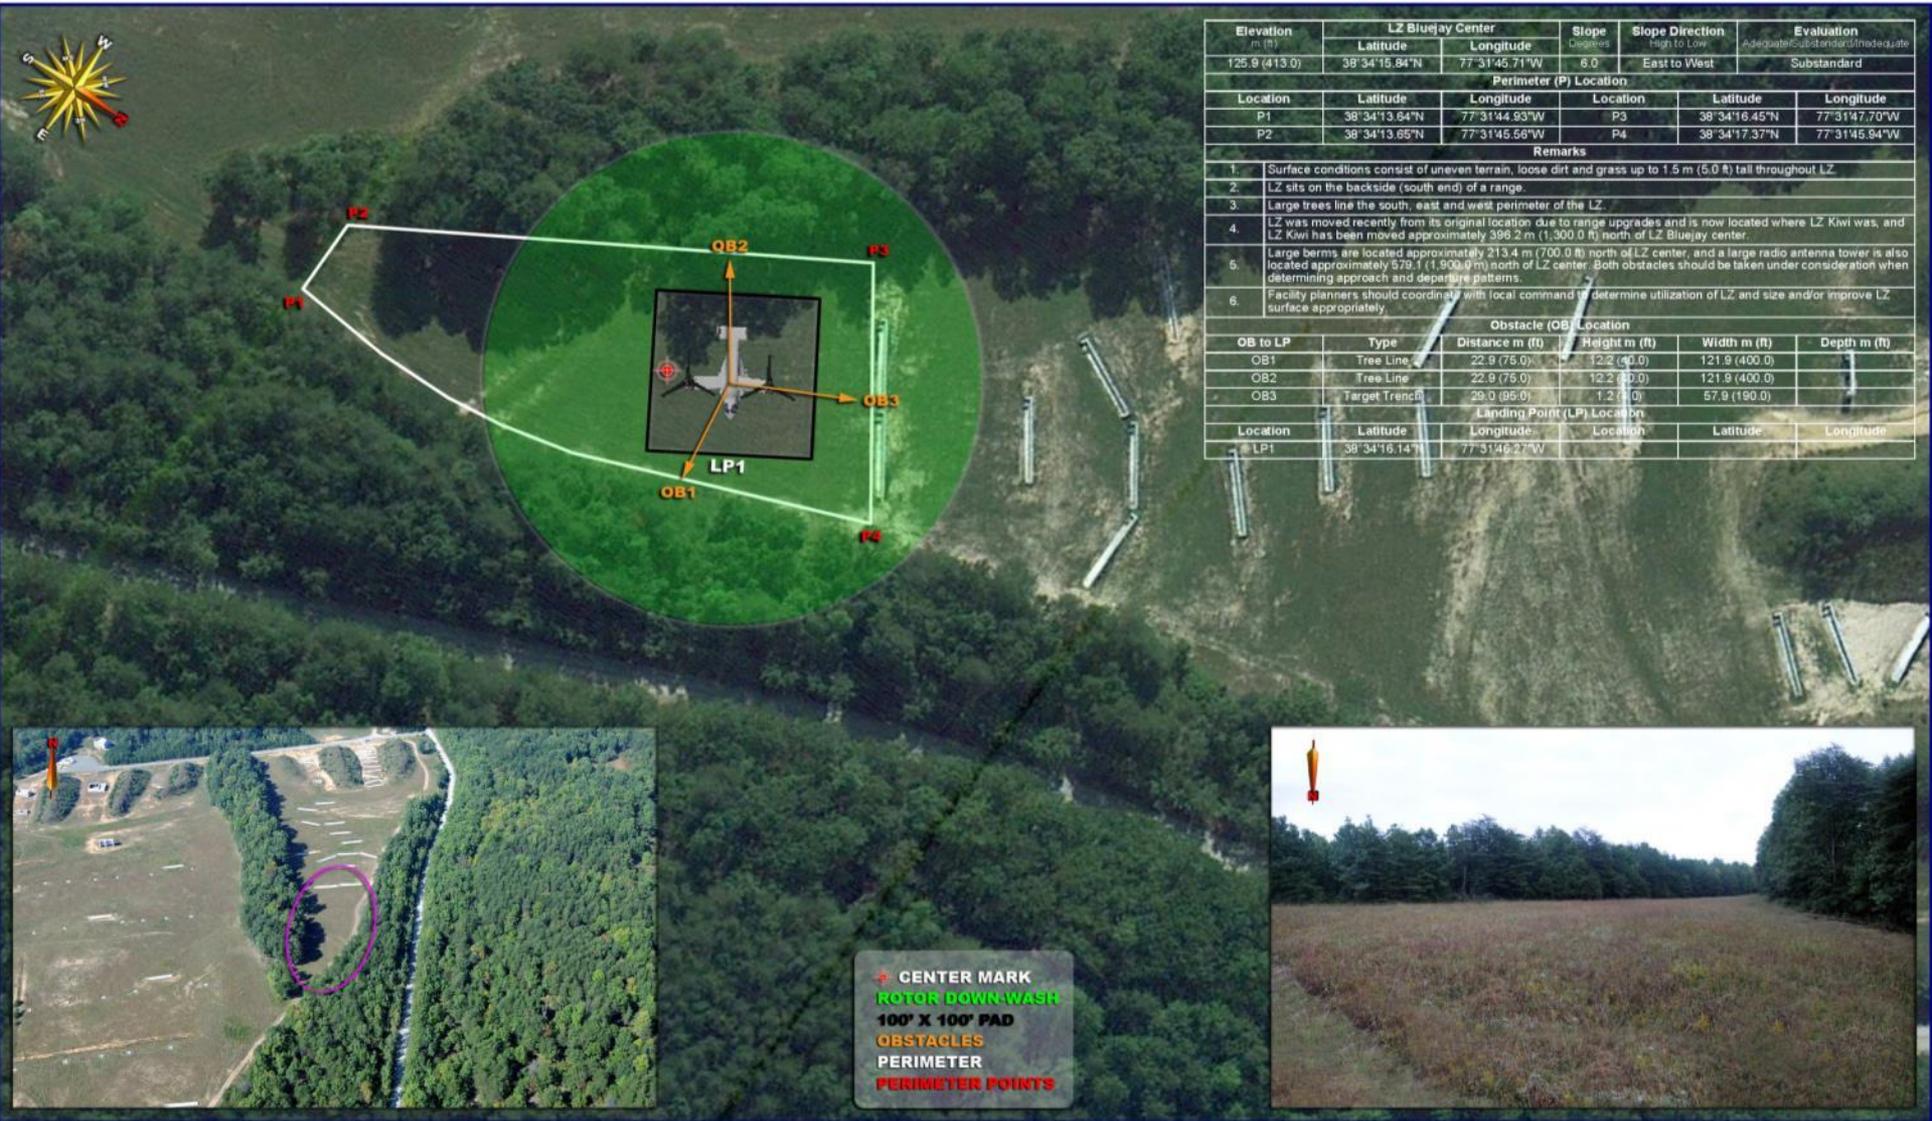
Elevation m (ft)	LZ Bluejay Center		Slope Degrees	Slope Direction High to Low	Evaluation Adequate/Substandard/Inadequate
	Latitude	Longitude			
125.9 (413.0)	38°34'15.84"N	77°31'45.71"W	6.0	East to West	Substandard
Perimeter (P) Location					
Location	Latitude	Longitude	Location	Latitude	Longitude
P1	38°34'13.64"N	77°31'44.93"W	P3	38°34'16.45"N	77°31'47.70"W
P2	38°34'13.65"N	77°31'45.56"W	P4	38°34'17.37"N	77°31'45.64"W
Remarks

1.	Surface conditions consist of uneven terrain, loose dirt and grass up to 1.5 m (5.0 ft) tall throughout LZ.				
2.	LZ sits on the backside (south end) of a range.

3.	Large trees line the south, east and west perimeter of the LZ.				
4.	LZ was moved recently from its original location due to range upgrades and is now located where LZ Kiwi was, and LZ Kiwi has been moved approximately 398.2 m (1,300.0 ft) north of LZ Bluejay center.

5.	Large berms are located approximately 213.4 m (700.0 ft) north of LZ center, and a large radio antenna tower is also located approximately 579.1 (1,900.0 m) north of LZ center. Both obstacles should be taken under consideration when determining approach and departure patterns.

6.	Facility planners should coordinate with local command to determine utilization of LZ and size and/or improve LZ surface appropriately.				
Obstacle (OB) Location					
OB to LP	Type	Distance m (ft)	Height m (ft)	Width m (ft)	Depth m (ft)
OB1	Tree Line	22.9 (75.0)	12.2 (40.0)	121.9 (400.0)	
OB2	Tree Line	22.9 (75.0)	12.2 (40.0)	121.9 (400.0)	
OB3	Target Trench	29.0 (95.0)	1.2 (4.0)	57.9 (190.0)	
Landing Point (LP) Location					
Location	Latitude	Longitude	Location	Latitude	Longitude
LP1	38°34'16.14"N	77°31'46.27"W

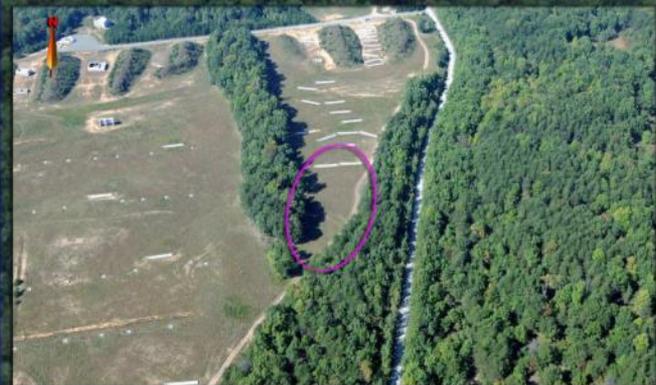
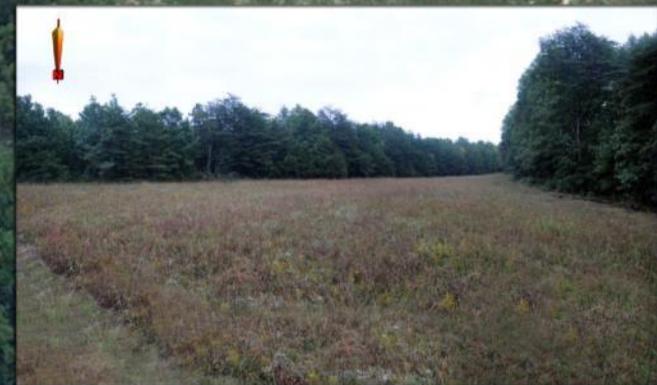
→ CENTER MARK  
 ROTOR DOWN WASH  
 100' X 100' PAD  
 OBSTACLES  
 PERIMETER  
 PERIMETER POINTS
