LZ CANARY

GRID: 845769

TA: 16B

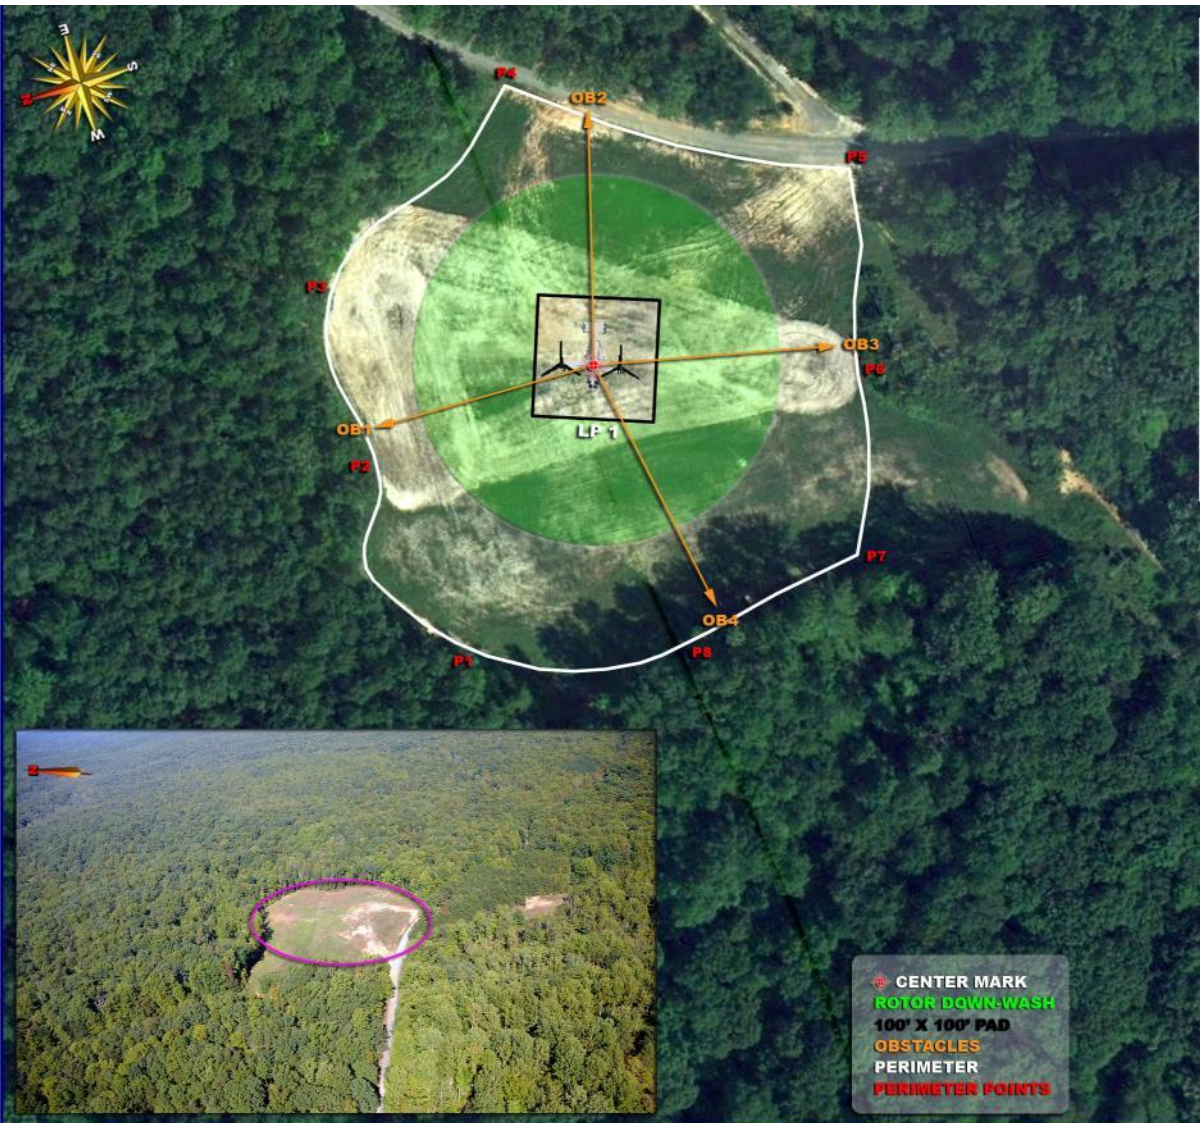
Elevation m (ft)	LZ Canary Center		Slope Degrees	Slope Direction High to Low	Evaluation Adequate/Substandard/Inadequate
	Latitude	Longitude			
110.0 (361.0)	38°36'53.77"N	77°28'29.91"W	Multiple	See Remarks	Substandard
Perimeter (P) Location					
Location	Latitude	Longitude	Location	Latitude	Longitude
P1	38°36'56.13"N	77°28'32.13"W	P5	38°36'51.71"N	77°28'28.73"W
P2	38°36'56.40"N	77°28'29.99"W	P6	38°36'52.29"N	77°28'30.92"W
P3	38°36'56.20"N	77°28'28.09"W	P7	38°36'52.94"N	77°28'32.66"W
P4	38°36'54.15"N	77°28'26.63"W	P8	38°36'54.11"N	77°28'32.87"W
Remarks

1.	Surface conditions consist of uneven terrain, loose dirt, gravel, and grass up to 0.9 m (3.0 ft) tall throughout LZ.				
2.	The LZ center is fairly level, however approximately 30.5 m (100.0 ft) out from LZ center in all directions the ground starts to slope downward causing a plateau affect.

3.	Large trees line the entire perimeter of the LZ.				
4.	The bird houses located throughout the LZ should be relocated closer to the perimeters to provide the proper safety clearances.

5.	Slopes range from < 1.0 degrees up to 12.0 degrees.				
6.	Facility planners should coordinate with local command to determine utilization of LZ and size and/or improve LZ surface appropriately.				
Obstacle (OB) Location					
OB to LP	Type	Distance m (ft)	Height m (ft)	Width m (ft)	Depth m (ft)
OB1	Tree Line	64.0 (210.0)	18.3 (60.0)	99.1 (325.0)	
OB2	Tree Line	68.6 (225.0)	18.3 (60.0)	115.8 (380.0)	
OB3	Tree Line	66.5 (215.0)	18.3 (60.0)	105.2 (345.0)	
OB4	Tree Line	76.2 (250.0)	18.3 (60.0)	109.7 (360.0)	
Landing Point (LP) Location					
Location	Latitude	Longitude	Location	Latitude	Longitude
LP1	38°36'53.77"N	77°28'29.91"W
