# LZ DRAKE

GRID: 805766

TA: 15C

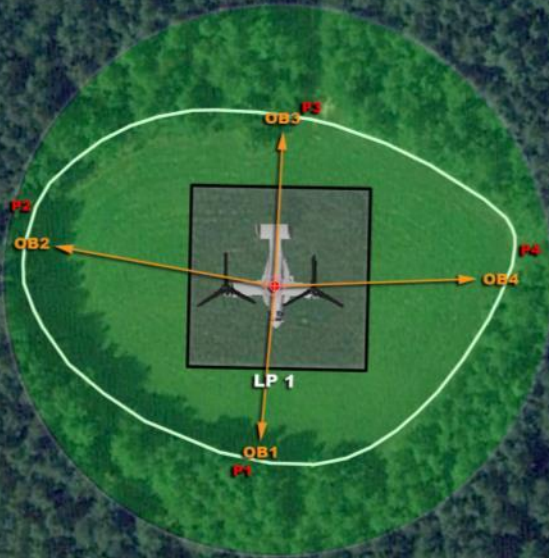
Elevation m (ft)	LZ Drake Center		Slope Degrees	Slope Direction High to Low	Evaluation Adequate/Standard/Inadequate
	Latitude	Longitude			
82.3 (270.0)	38°36'38.73"N	77°31'14.69"W	4.0	South to North	Substandard
Perimeter (P) Location					
Location	Latitude	Longitude	Location	Latitude	Longitude
P1	38°36'37.67"N	77°31'15.20"W	P3	38°36'38.68"N	77°31'14.69"W
P2	38°36'39.10"N	77°31'16.61"W	P4	38°36'38.70"N	77°31'13.15"W
Remarks

1.	Surface conditions consist of loose dirt and grass up to 0.9 m (3.0 ft) tall throughout the LZ.				
2.	Large trees line the entire perimeter of the LZ.

3.	Large power lines are located approximately 975.4 m (3,200.0 ft) northwest of LZ center and should be considered when determining approach and departure patterns.

4.	Facility planners should coordinate with local command to determine utilization of LZ and size and/or improve LZ surface appropriately.				
Obstacle (OB) Location					
OB to LP	Type	Distance m (ft)	Height m (ft)	Width m (ft)	Depth m (ft)
OB1	Tree Line	27.4 (90.0)	18.3 (60.0)	57.9 (190.0)	
OB2	Tree Line	41.1 (135.0)	19.3 (60.0)	41.1 (135.0)	
OB3	Tree Line	27.4 (90.0)	18.3 (60.0)	57.9 (190.0)	
OB4	Tree Line	35.1 (115.0)	18.3 (60.0)	41.1 (135.0)	
Landing Point (LP) Location					
Location	Latitude	Longitude	Location	Latitude	Longitude
LP1	38°36'38.73"N	77°31'14.69"W

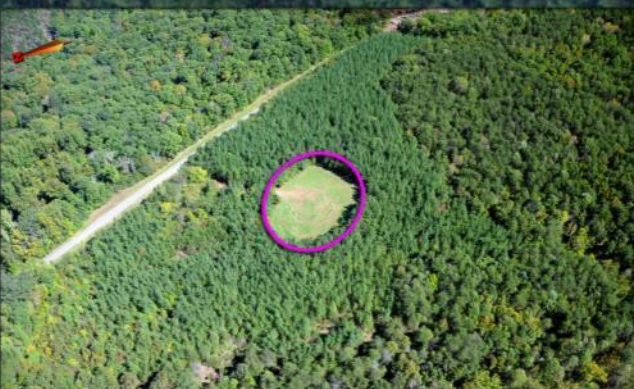
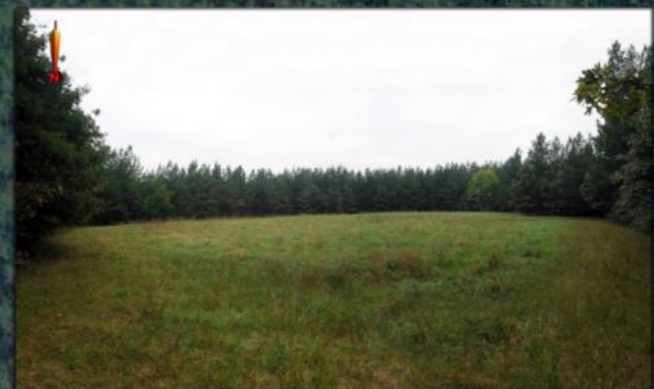
→ CENTER MARK  
 ROTOR DOWNWASH  
 100' X 100' PAD  
 OBSTACLES  
 PERIMETER  
 PERIMETER POINTS
