LZ EGRET

GRID: 782727

TA: 14B

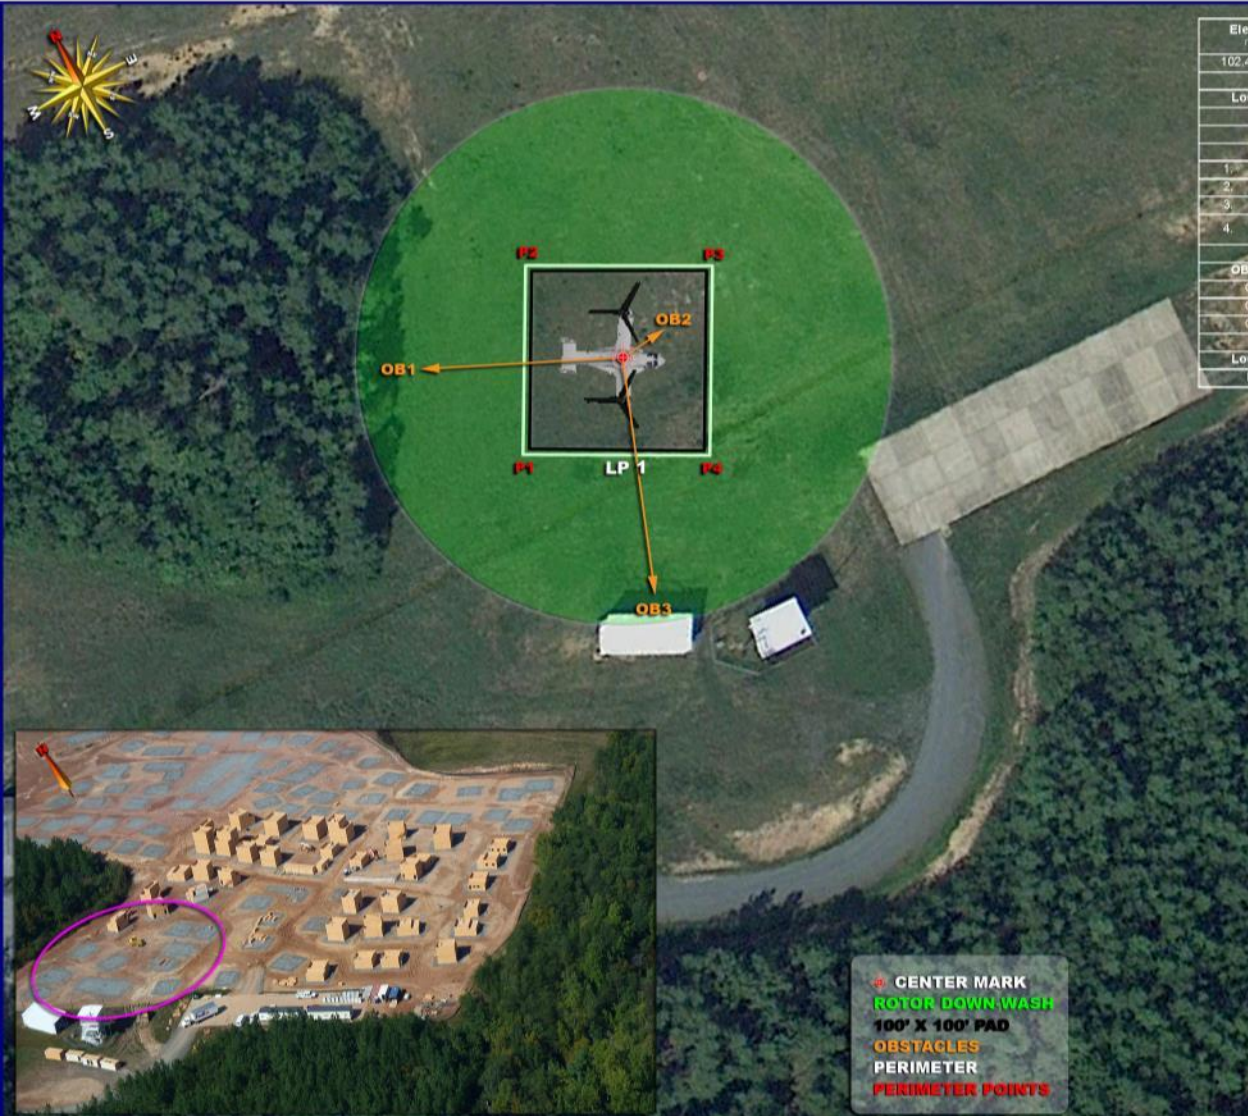
Elevation m (ft)	LZ Egret Center		Slope Original	Slope Direction High to Low	Evaluation Adequate/Unsuitable/Inadequate
	Latitude	Longitude			
102.4 (336.0)	38°34'23.94"N	77°32'41.59"W	N/A	N/A	Inadequate
Perimeter (P) Location					
Location	Latitude	Longitude	Location	Latitude	Longitude
P1	38°34'24.20"N	77°32'42.11"W	P3	38°34'24.64"N	77°32'40.27"W
P2	38°34'26.16"N	77°32'41.47"W	P4	38°34'23.71"N	77°32'40.88"W
Remarks

1. Surface conditions consist of loose dirt and gravel.					
2. The LZ is being turned into an urban city training area and could not be fully surveyed.

3. Area is not suitable to support MV-22 operations.					
4. Facility planners should coordinate with local command to determine utilization of LZ and size and/or improve LZ surface appropriately.					
Obstacle (OB) Location					
OB to LP	Type	Distance m (ft)	Height m (ft)	Width m (ft)	Depth m (ft)
OB1	Tree Line	36.6 (120.0)	18.3 (60.0)	79.2 (260.0)	
OB2	Buildings	3.0 (10.0)	Multiple	Entire LZ	Entire LZ
OB3	Range Tower	45.7 (150.0)	15.2 (50.0)	6.1 (20.0)	6.1 (20.0)
Landing Point (LP) Location					
Location	Latitude	Longitude	Location	Latitude	Longitude
LP1	38°34'23.94"N	77°32'41.59"W
