LZ GOOSE

GRID: 797754

TA: 15A

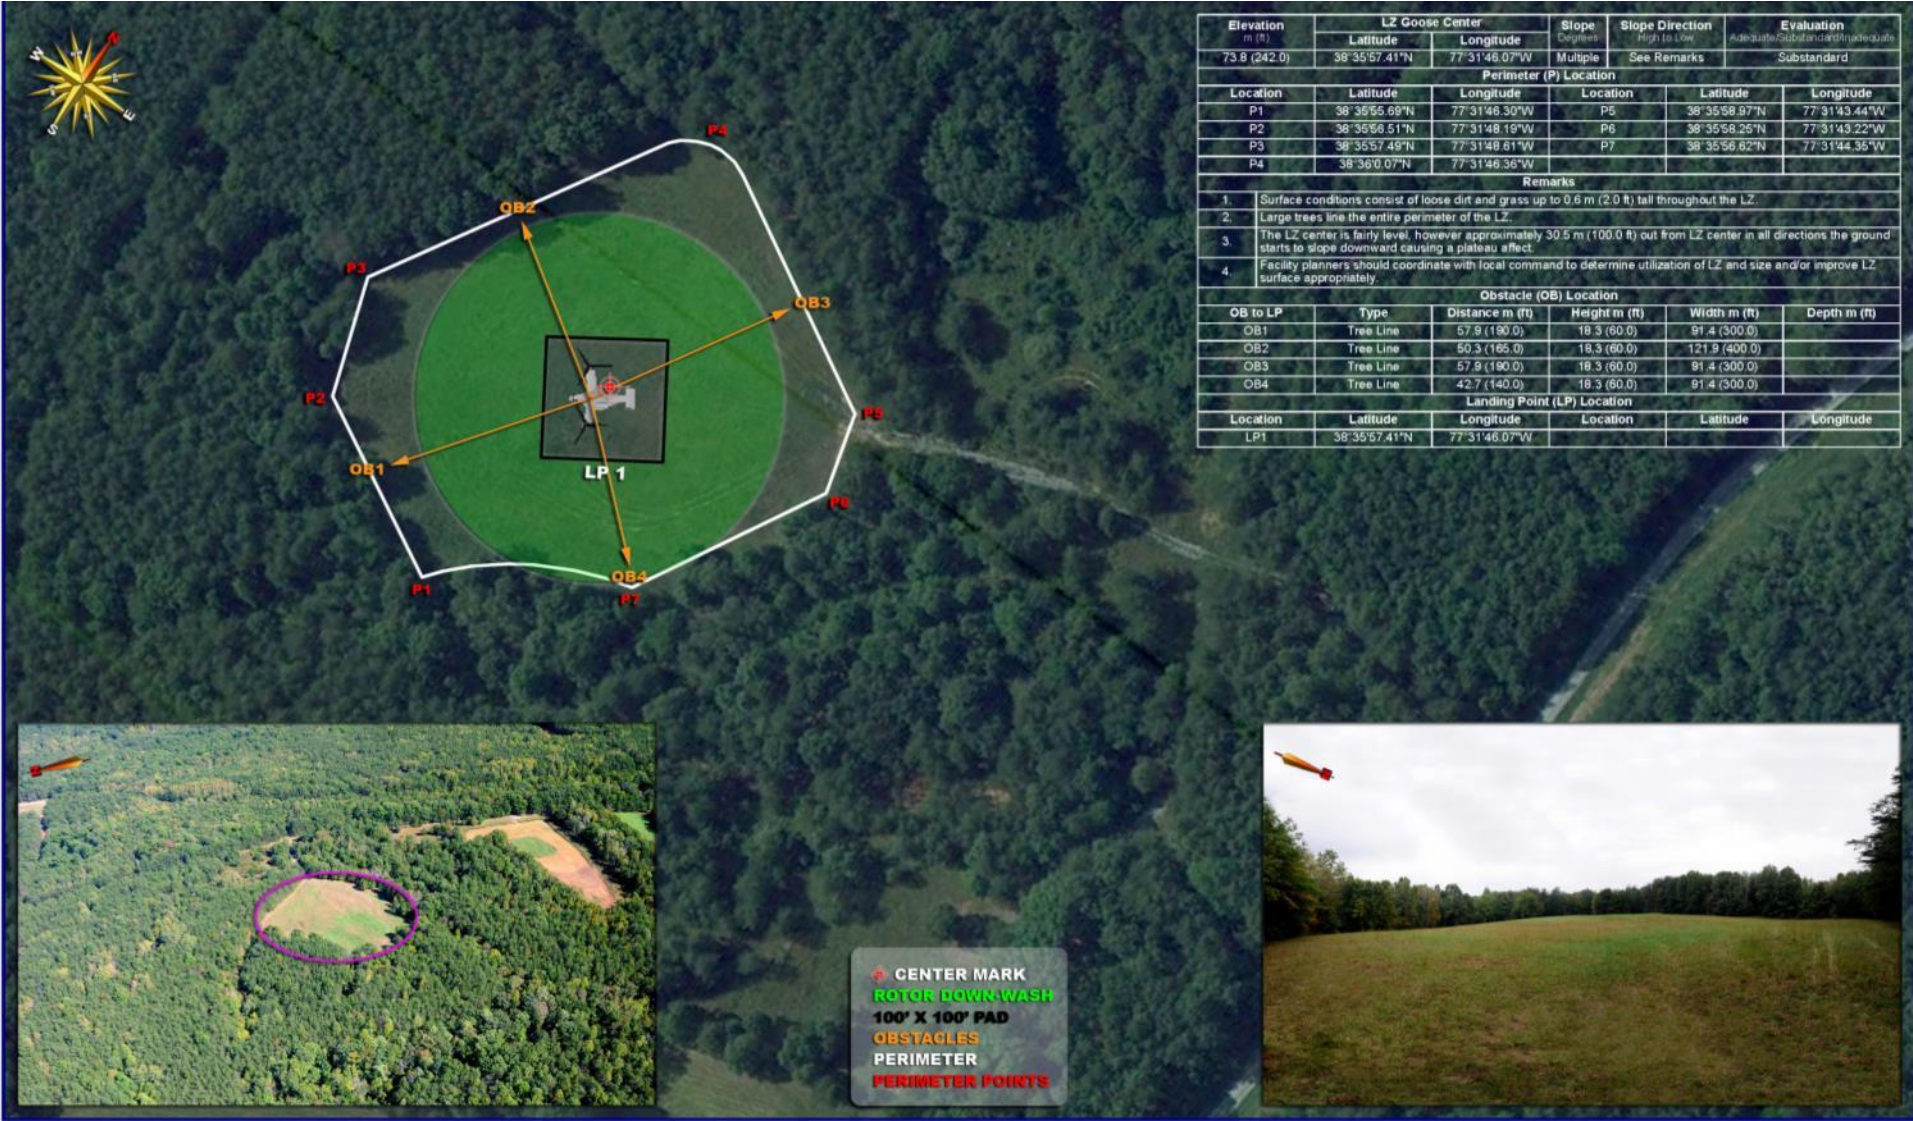
Elevation m (ft)	LZ Goose Center		Slope Degrees	Slope Direction High to Low	Evaluation Adequate/Substandard/Inadequate
	Latitude	Longitude			
73.8 (242.0)	38°35'57.41"N	77°31'46.07"W	Multiple	See Remarks	Substandard
Perimeter (P) Location					
Location	Latitude	Longitude	Location	Latitude	Longitude
P1	38°35'56.69"N	77°31'46.30"W	P5	38°35'58.97"N	77°31'43.44"W
P2	38°35'56.51"N	77°31'48.19"W	P6	38°35'58.26"N	77°31'43.22"W
P3	38°35'57.49"N	77°31'48.61"W	P7	38°35'56.62"N	77°31'44.35"W
P4	38°36'0.07"N	77°31'46.36"W			
Remarks

1. Surface conditions consist of loose dirt and grass up to 0.6 m (2.0 ft) tall throughout the LZ.					
2. Large trees line the entire perimeter of the LZ.

3. The LZ center is fairly level, however approximately 30.5 m (100.0 ft) out from LZ center in all directions the ground starts to slope downward causing a plateau affect.

4. Facility planners should coordinate with local command to determine utilization of LZ and size and/or improve LZ surface appropriately.					
Obstacle (OB) Location					
OB to LP	Type	Distance m (ft)	Height m (ft)	Width m (ft)	Depth m (ft)
OB1	Tree Line	57.9 (190.0)	19.3 (60.0)	91.4 (300.0)	
OB2	Tree Line	50.3 (165.0)	19.3 (60.0)	121.9 (400.0)	
OB3	Tree Line	57.9 (190.0)	19.3 (60.0)	91.4 (300.0)	
OB4	Tree Line	42.7 (140.0)	19.3 (60.0)	91.4 (300.0)	
Landing Point (LP) Location					
Location	Latitude	Longitude	Location	Latitude	Longitude
LP1	38°35'57.41"N	77°31'46.07"W
