# LZ HARRIER

GRID: 874738

TA: 16G

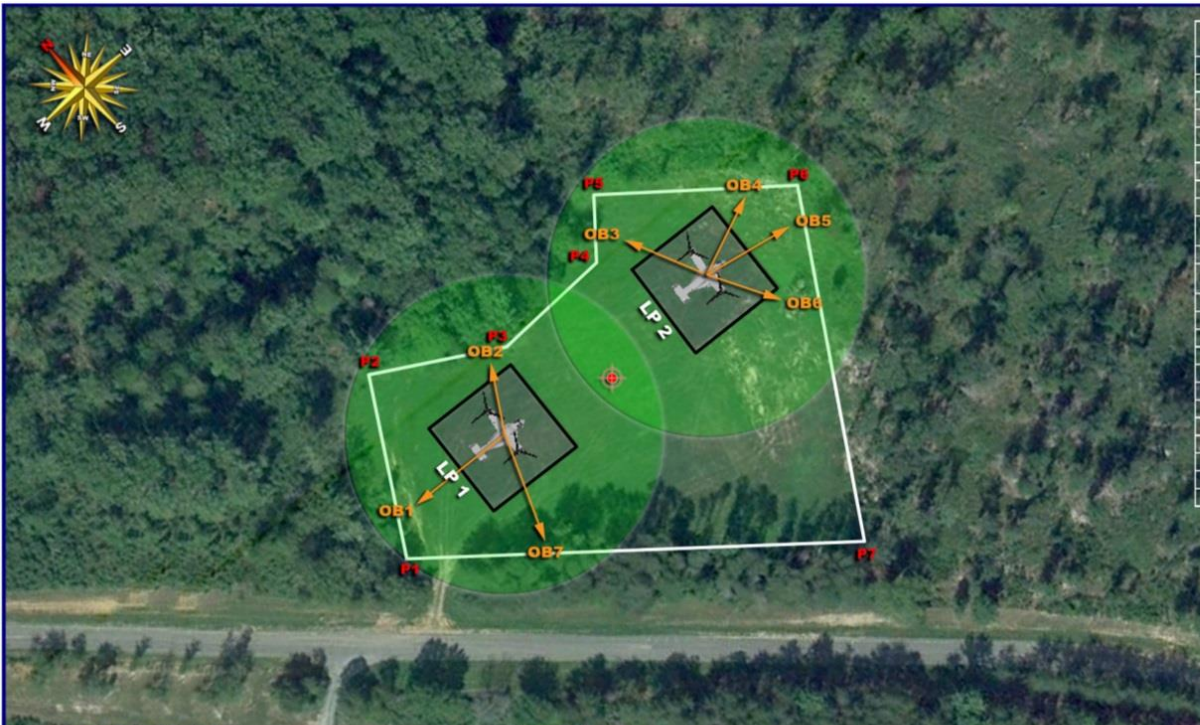
Elevation m (ft)	LZ Harrier Center		Slope Degrees	Slope Direction High to Low	Evaluation Adequate/Substandard/Inadequate
	Latitude	Longitude			
120.1 (394.0)	38°35'13.78"N	77°26'25.95"W	2.5	East to West	Substandard
Perimeter (P) Location					
Location	Latitude	Longitude	Location	Latitude	Longitude
P1	38°35'13.55"N	77°26'28.38"W	P5	38°35'15.20"N	77°26'24.72"W
P2	38°35'15.19"N	77°26'28.33"W	P6	38°35'14.05"N	77°26'22.63"W
P3	38°35'14.58"N	77°26'26.75"W	P7	38°35'10.98"N	77°26'24.73"W
P4	38°35'14.67"N	77°26'25.19"W			
Remarks

1.	Surface conditions consist of loose dirt and grass up to 0.9 m (3.0 ft) tall throughout the LZ.				
2.	There is a large pile of debris located northeast corner of the LZ and should be removed to provide the proper safety clearances.

3.	Large trees line the entire perimeter of the LZ.				
4.	Facility planners should coordinate with local command to determine utilization of LZ and size and/or improve LZ surface appropriately.				
Obstacle (OB) Location					
OB to LP	Type	Distance m (ft)	Height m (ft)	Width m (ft)	Depth m (ft)
OB1-(LP1)	Tree Line	36.6 (120.0)	18.3 (60.0)	22.9 (75.0)	
OB2-(LP1)	Tree Line	24.4 (80.0)	18.3 (60.0)	61.0 (200.0)	
OB3-(LP2)	Tree Line	30.5 (100.0)	18.3 (60.0)	48.8 (160.0)	
OB4-(LP2)	Tree Line	30.5 (100.0)	18.3 (60.0)	41.1 (135.0)	
OB5-(LP2)	Tree Line	35.1 (115.0)	18.3 (60.0)	61.0 (200.0)	
OB6-(LP2)	Pile of Debris	21.3 (70.0)	4.6 (15.0)	11.0 (36.0)	7.6 (25.0)
OB7-(LP1)	Tree Line	25.9 (85.0)	18.3 (60.0)	131.1 (430.0)	
Landing Point (LP) Location					
Location	Latitude	Longitude	Location	Latitude	Longitude
LP1	38°35'13.89"N	77°26'27.45"W	LP2	38°35'13.90"N	77°26'24.21"W
