# LZ HAWK

GRID: 916640

TA: 5B

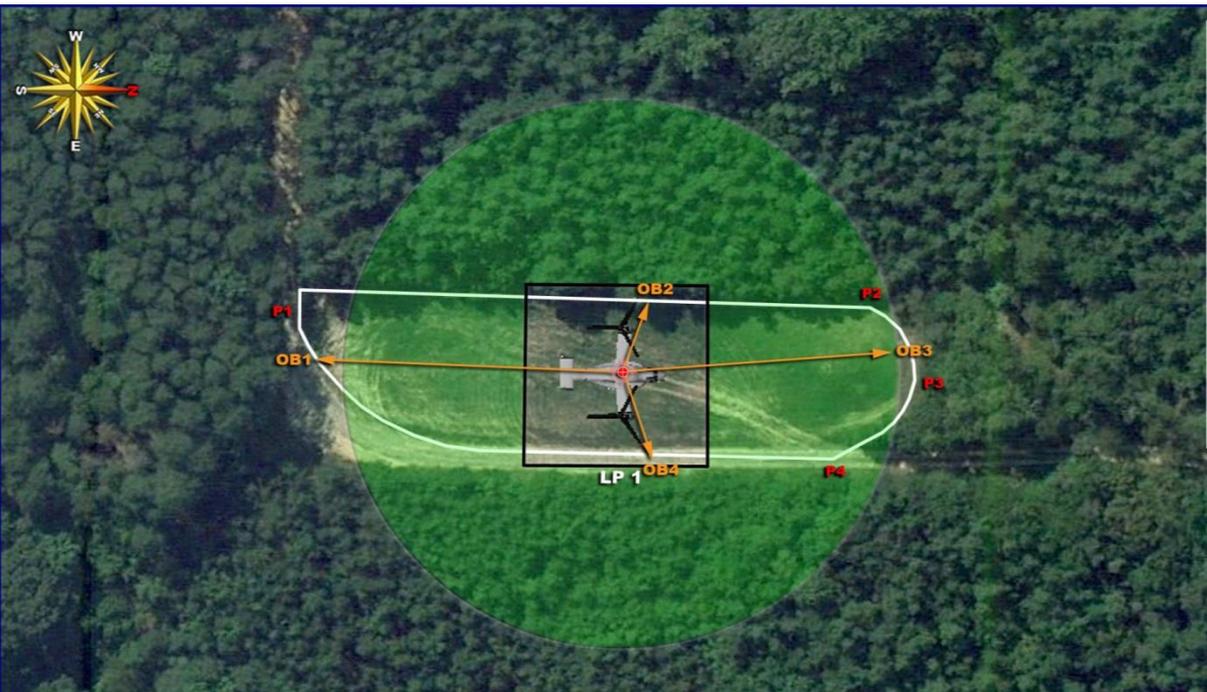
1.	Surface conditions consist of loose dirt and grass up to 0.9 m (3.0 ft) tall throughout the LZ.				
2.	Large trees line the entire perimeter of the LZ.

3.	A major highway is located approximately 579.1 m (1,900.0 ft) east of LZ center and a large office building complex is located approximately 752.9 m (2,470.0 ft) north of LZ center. Both obstacles should be considered when determining approach and departure patterns.

4.	Area is not suitable to support MV-22 operations.				
5.	Facility planners should coordinate with local command to determine utilization of LZ and size and/or improve LZ surface appropriately.				
Obstacle (OB) Location					
OB to LP	Type	Distance m (ft)	Height m (ft)	Width m (ft)	Depth m (ft)
OB1	Tree Line	54.9 (180.0)	18.3 (60.0)	30.5 (100.0)	
OB2	Tree Line	10.7 (35.0)	18.3 (60.0)	106.7 (350.0)	
OB3	Tree Line	50.3 (165.0)	18.3 (60.0)	30.5 (100.0)	
OB4	Tree Line	16.8 (55.0)	18.3 (60.0)	106.7 (350.0)	
Landing Point (LP) Location					
Location	Latitude	Longitude	Location	Latitude	Longitude
LP1	38°30'1.43"N	77°23'18.45"W
