LZ HUMMINGBIRD

GRID: 790747

TA: 15A

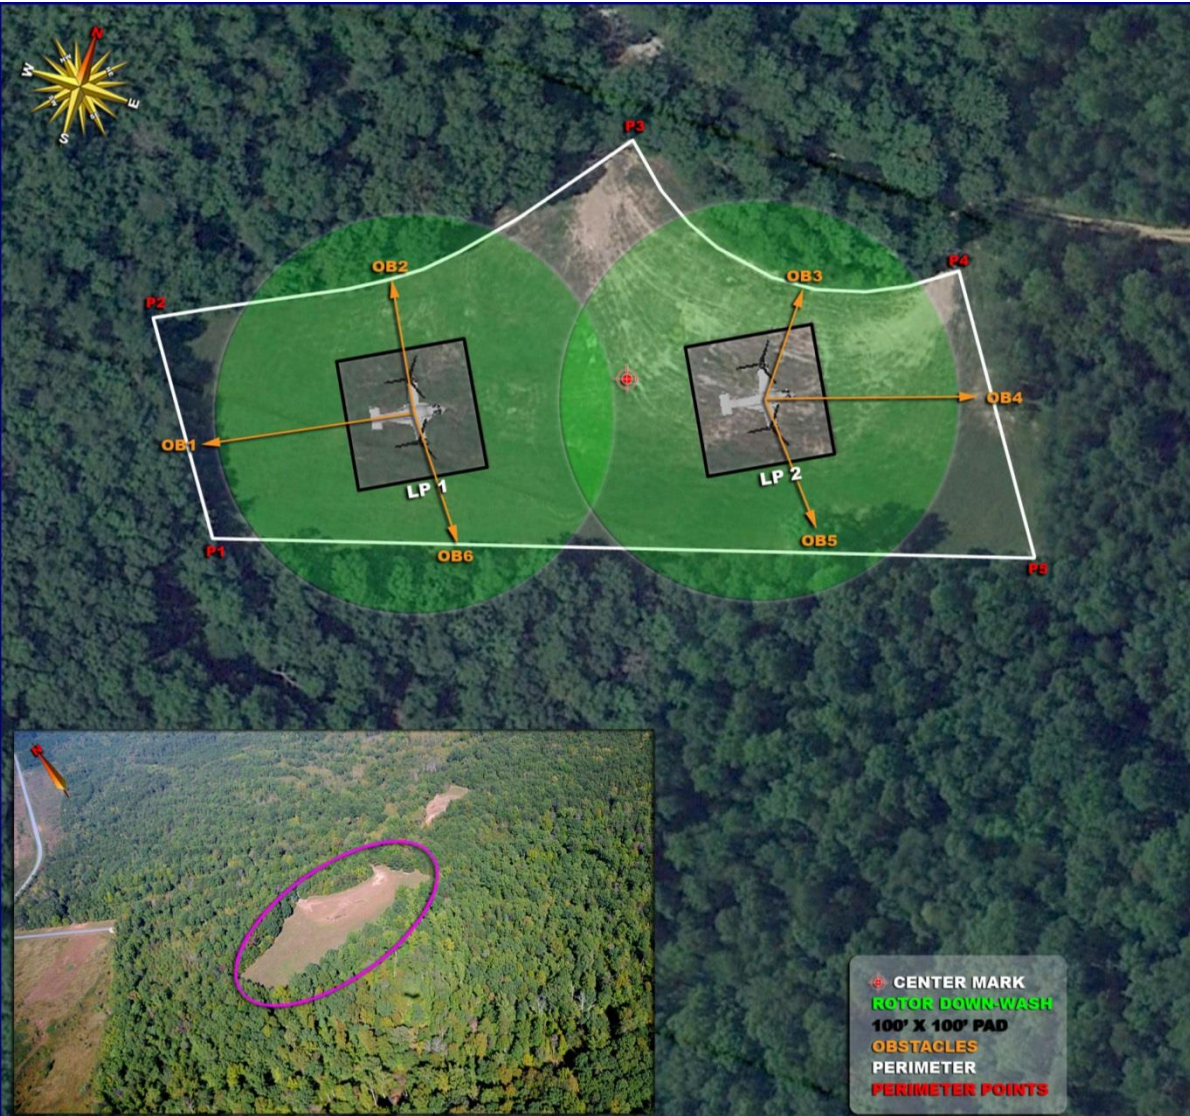
Elevation m (ft)	LZ Hummingbird Center		Slope Degrees	Slope Direction High to Low	Evaluation Adequate/Substandard/Inadequate
	Latitude	Longitude			
118.3 (388.0)	38°35'35.47"N	77°32'14.67"W	5.0	North to South	Substandard
Perimeter (P) Location					
Location	Latitude	Longitude	Location	Latitude	Longitude
P1	38°35'33.24"N	77°32'18.58"W	P4	38°35'36.97"N	77°32'12.36"W
P2	38°35'34.70"N	77°32'19.83"W	P5	38°35'35.05"N	77°32'10.73"W
P3	38°35'37.19"N	77°32'16.81"W			
Remarks

1.	Surface conditions consist of uneven terrain, loose dirt and grass up to 0.9 m (3.0 ft) tall throughout the LZ.				
2.	Large trees line the entire perimeter of the LZ.

3.	The center of the LZ has a couple low areas do to vehicle ruts.				
4.	Facility planners should coordinate with local command to determine utilization of LZ and size and/or improve LZ surface appropriately.				
Obstacle (OB) Location					
OB to LP	Type	Distance m (ft)	Height m (ft)	Width m (ft)	Depth m (ft)
OB1-(LP1)	Tree Line	50.3 (165.0)	18.3 (60.0)	57.9 (190.0)	
OB2-(LP1)	Tree Line	29.0 (95.0)	18.3 (60.0)	121.9 (400.0)	
OB3-(LP2)	Tree Line	27.4 (90.0)	18.3 (60.0)	80.9 (265.0)	
OB4-(LP2)	Tree Line	53.3 (175.0)	18.3 (60.0)	70.1 (230.0)	
OB5-(LP2)	Tree Line	22.9 (75.0)	18.3 (60.0)	195.1 (640.0)	
OB6-(LP1)	Tree Line	30.5 (100.0)	18.3 (60.0)	195.1 (640.0)	
Landing Point (LP) Location					
Location	Latitude	Longitude	Location	Latitude	Longitude
LP1	38°35'34.63"N	77°32'17.05"W	LP2	38°35'35.59"N	77°32'13.76"W
