# LZ PARROT

GRID: 788734

TA: 14B

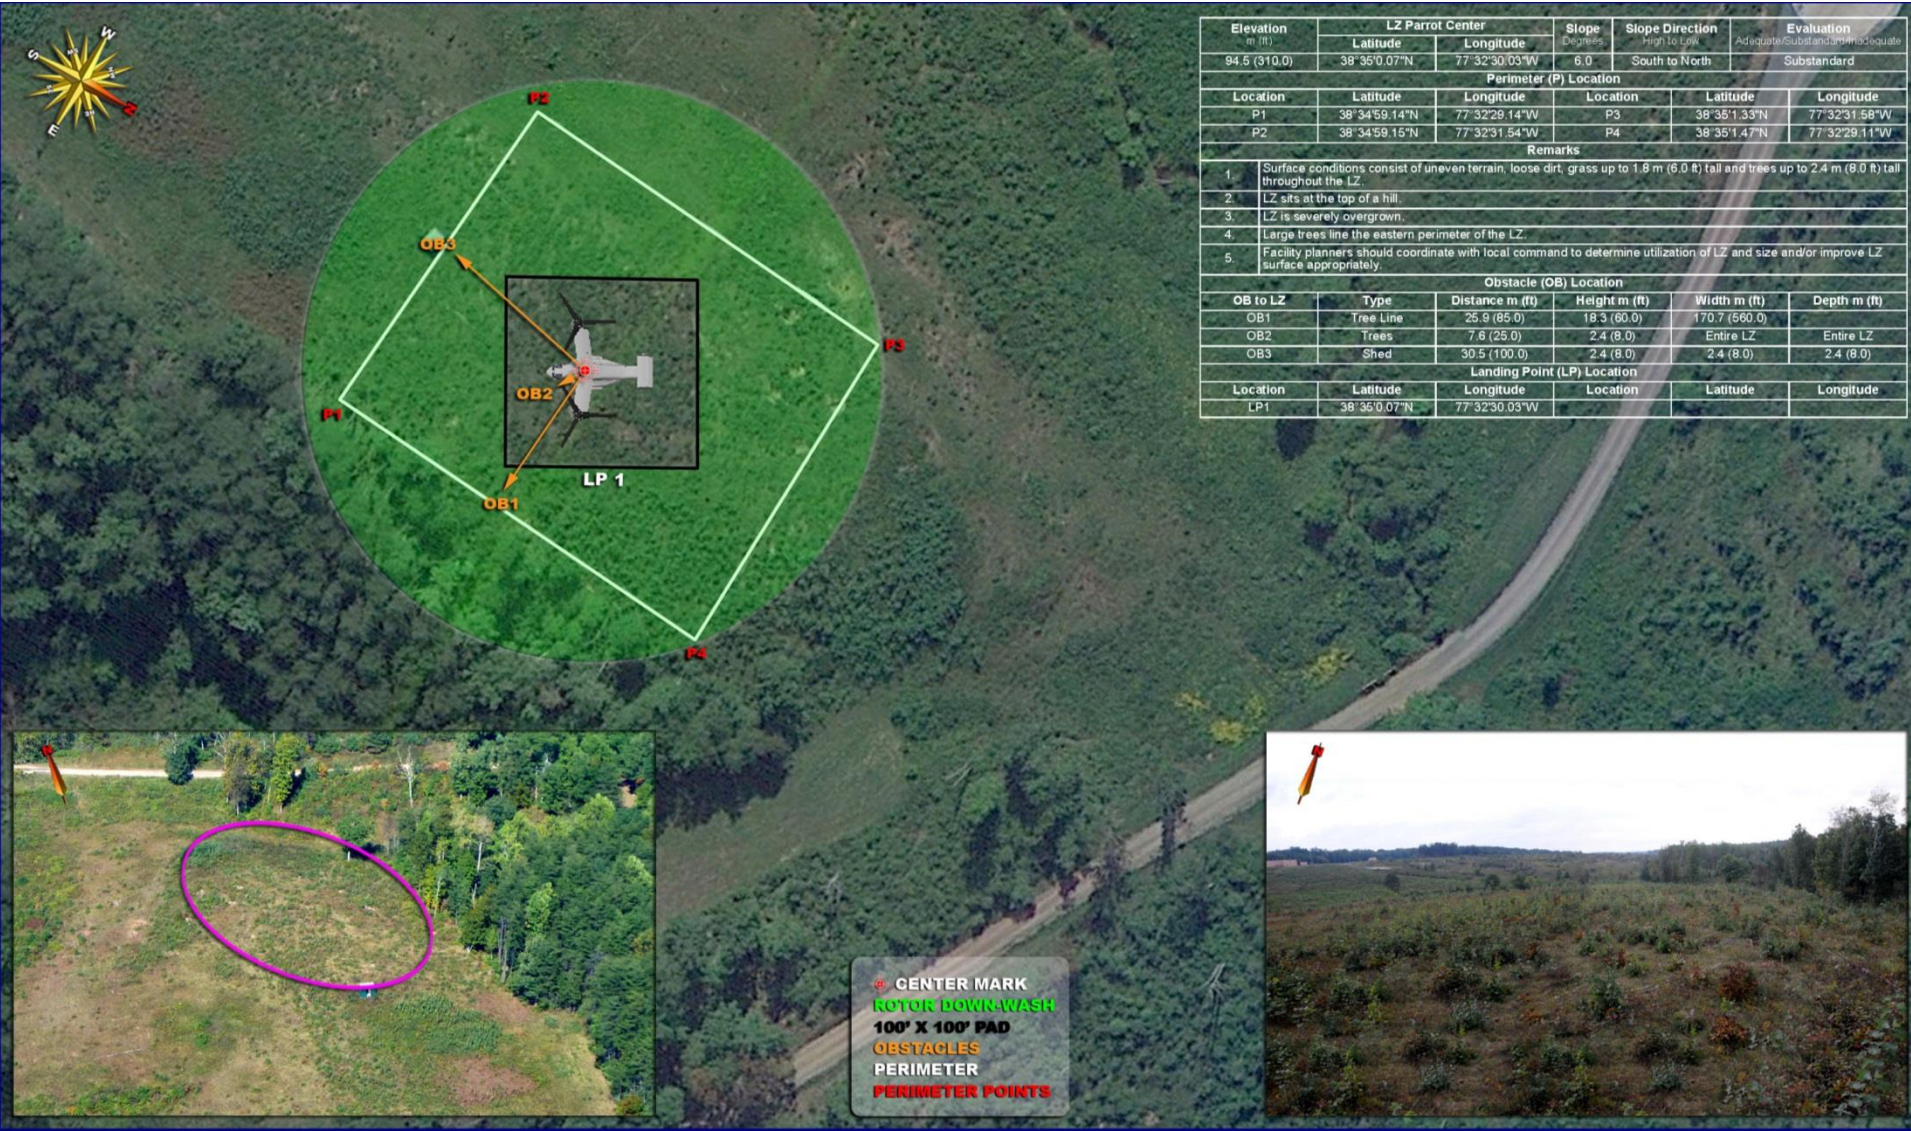
Elevation m (ft)	LZ Parrot Center		Slope Degrees	Slope Direction High to Low	Evaluation Adequate/Substandard/Inadequate
	Latitude	Longitude			
94.5 (310.0)	38°35'0.07"N	77°32'30.03"W	6.0	South to North	Substandard
Perimeter (P) Location					
Location	Latitude	Longitude	Location	Latitude	Longitude
P1	38°34'59.14"N	77°32'29.14"W	P3	38°35'1.33"N	77°32'31.58"W
P2	38°34'59.15"N	77°32'31.54"W	P4	38°35'1.47"N	77°32'29.11"W
Remarks

1.	Surface conditions consist of uneven terrain, loose dirt, grass up to 1.8 m (6.0 ft) tall and trees up to 2.4 m (8.0 ft) tall throughout the LZ.

2.	LZ sits at the top of a hill.				
3.	LZ is severely overgrown.				
4.	Large trees line the eastern perimeter of the LZ.				
5.	Facility planners should coordinate with local command to determine utilization of LZ and size and/or improve LZ surface appropriately.				
Obstacle (OB) Location					
OB to LZ	Type	Distance m (ft)	Height m (ft)	Width m (ft)	Depth m (ft)
OB1	Tree Line	25.9 (85.0)	18.3 (60.0)	170.7 (560.0)	
OB2	Trees	7.6 (25.0)	2.4 (8.0)	Entire LZ	Entire LZ
OB3	Shed	30.5 (100.0)	2.4 (8.0)	2.4 (8.0)	2.4 (8.0)
Landing Point (LP) Location					
Location	Latitude	Longitude	Location	Latitude	Longitude
LP1	38°35'0.07"N	77°32'30.03"W
