LZ PHEASANT

GRID: 821778

TA: 16A

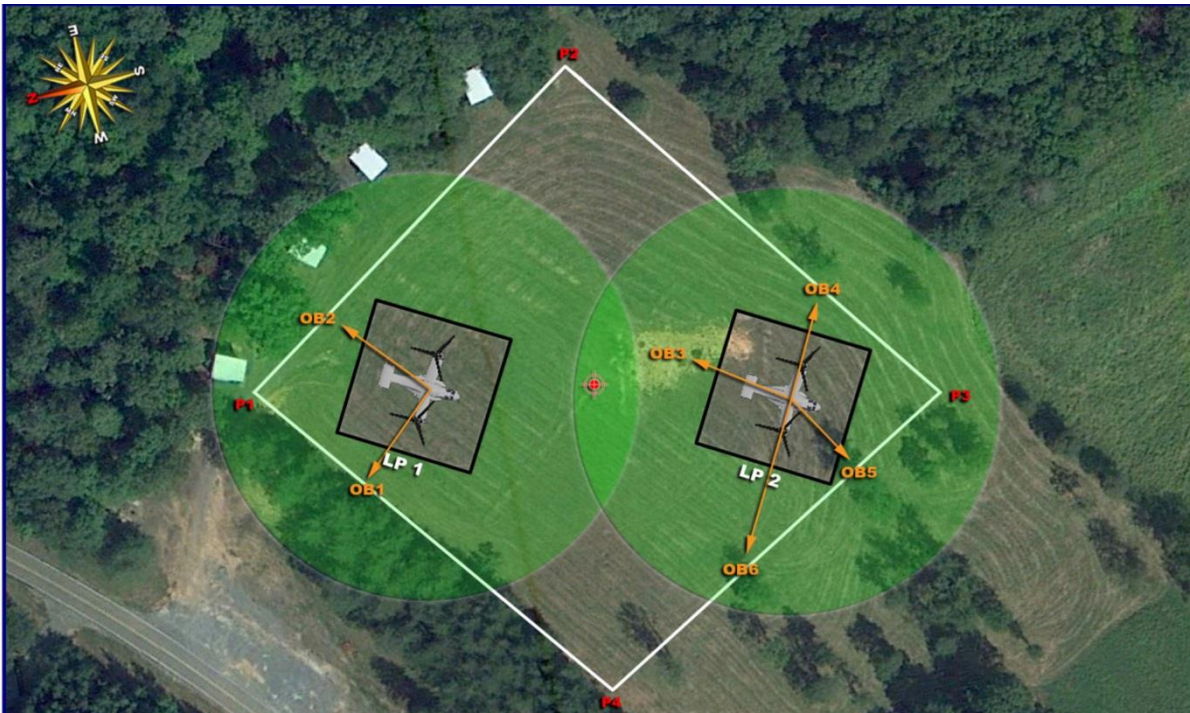
Elevation m (ft)	LZ Pheasant Center		Slope Degrees	Slope Direction High to Low	Evaluation Adequate/Substandard/Inadequate
	Latitude	Longitude			
94.5 (310.0)	38°37'22.04"N	77°30'10.89"W	2.5	South to North	Substandard
Perimeter (P) Location					
Location	Latitude	Longitude	Location	Latitude	Longitude
P1	38°37'24.26"N	77°30'10.10"W	P3	38°37'19.38"N	77°30'11.46"W
P2	38°37'21.56"N	77°30'7.75"W	P4	38°37'22.17"N	77°30'13.52"W
Remarks

1. Surface conditions consist of uneven terrain, loose dirt and grass up to 1.2 m (2.0 ft) tall throughout the LZ.					
2. Large trees line the entire perimeter of the LZ.

3. Large power lines are located approximately 844.9 m (3,100.0 ft) northwest of LZ center and should be considered when determining approach and departure patterns.

4. Facility planners should coordinate with local command to determine utilization of LZ and size and/or improve LZ surface appropriately.					
Obstacle (OB) Location					
OB to LP	Type	Distance m (ft)	Height m (ft)	Width m (ft)	Depth m (ft)
OB1-(LP1)	Tree Line	24.4 (80.0)	18.3 (60.0)	115.8 (380.0)	
OB2-(LP1)	Tree Line	27.4 (90.0)	18.3 (60.0)	109.7 (360.0)	
OB3-(LP2)	Low Area	19.8 (65.0)	1.2 (4.0)	24.4 (80.0)	15.2 (50.0)
OB4-(LP2)	Tree Line	25.9 (85.0)	18.3 (60.0)	106.7 (350.0)	
OB5-(LP2)	Tree Line	15.2 (50.0)	18.3 (60.0)	83.8 (275.0)	
OB6-(LP2)	Tree Line	36.6 (120.0)	18.3 (60.0)	83.8 (275.0)	
Landing Point (LP) Location					
Location	Latitude	Longitude	Location	Latitude	Longitude
LP1	38°37'23.01"N	77°30'10.42"W	LP2	38°37'20.45"N	77°30'11.23"W
