LZ STARLING

GRID: 908653

TA: 5A

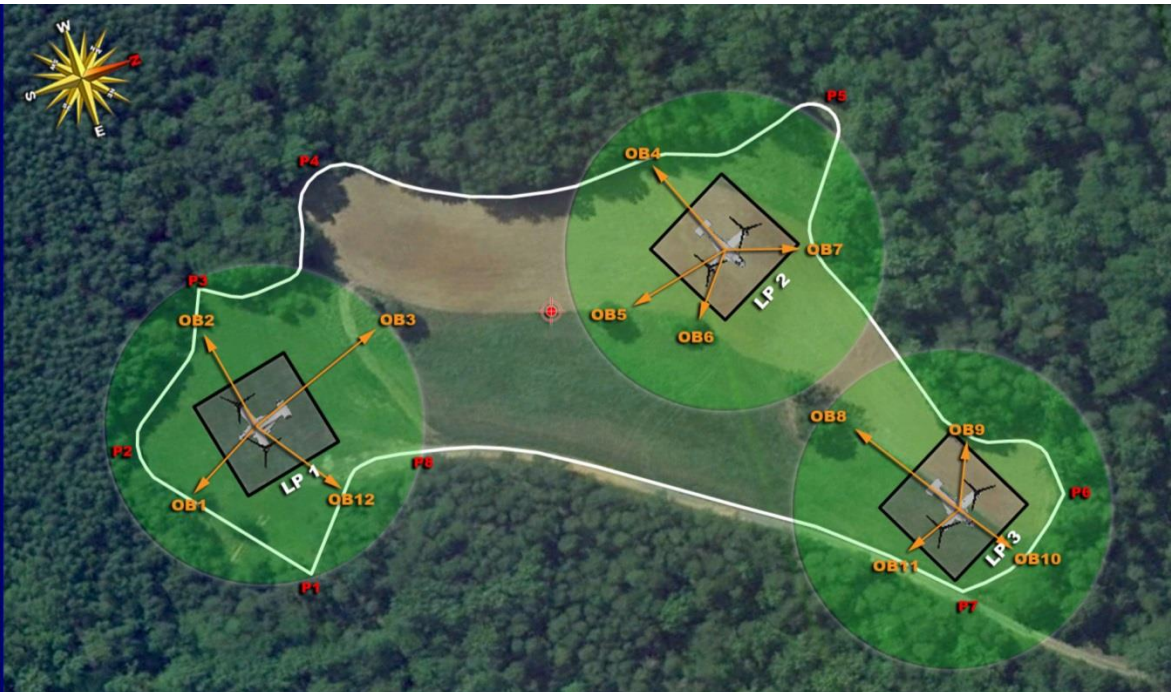
Elevation m (ft)	LZ Starling Center		Slope Degrees	Slope Direction High to Low	Evaluation Adequate/Substandard/Inadequate
	Latitude	Longitude			
68.0 (223.0)	38° 30' 43.80" N	77° 23' 59.18" W	Multiple	See Remarks	Substandard

Obstacle (OB) Location					
OB to LP	Type	Distance m (ft)	Height m (ft)	Width m (ft)	Depth m (ft)
OB1-(LP1)	Tree Line	24.4 (80.0)	18.3 (60.0)	59.4 (195.0)	
OB2-(LP1)	Tree Line	29.0 (95.0)	18.3 (60.0)	61.0 (200.0)	
OB3-(LP1)	Tree	45.7 (150.0)	6.1 (20.0)	10.7 (35.0)	6.1 (20.0)
OB4-(LP2)	Tree Line	33.5 (110.0)	18.3 (60.0)	100.6 (330.0)	
OB5-(LP2)	Tree	33.5 (110.0)	6.1 (20.0)	6.1 (20.0)	6.1 (20.0)
OB6-(LP2)	Tree	19.8 (65.0)	6.1 (20.0)	6.1 (20.0)	6.1 (20.0)
OB7-(LP2)	Tree Line	24.4 (80.0)	18.3 (60.0)	64.0 (210.0)	
OB8-(LP3)	Trees	39.6 (130.0)	6.1 (20.0)	15.2 (50.0)	18.3 (60.0)
OB9-(LP3)	Tree Line	18.3 (60.0)	18.3 (60.0)	38.1 (125.0)	
OB10-(LP3)	Tree Line	22.9 (75.0)	18.3 (60.0)	32.0 (105.0)	
OB11-(LP3)	Tree Line	22.9 (75.0)	18.3 (60.0)	134.1 (440.0)	
OB12-(LP1)	Tree Line	29.0 (95.0)	18.3 (60.0)	57.9 (190.0)

Remarks					
1.	Surface conditions consist of uneven terrain, loose dirt and grass up to 1.2 m (4.0 ft) tall throughout the LZ.				
2.	Large trees line the entire perimeter of the LZ.				
3.	A line of trees up to 6.1 m (20.0 ft) tall run southwest to northeast down the center of the LZ.				
4.	The bird houses located throughout the LZ should be relocated closer to the perimeters to provide the proper safety clearances.				
5.	A major highway is located approximately 1989.8 m (6,200.0 ft) east of LZ center and a large office building complex is located approximately 518.2 m (1,700.0 ft) east of LZ center. Both obstacles should be considered when determining approach and departure patterns.				
6.	Facility planners should coordinate with local command to determine utilization of LZ and size and/or improve LZ surface appropriately.
