LZ STORK

GRID: 786759

TA: 15C

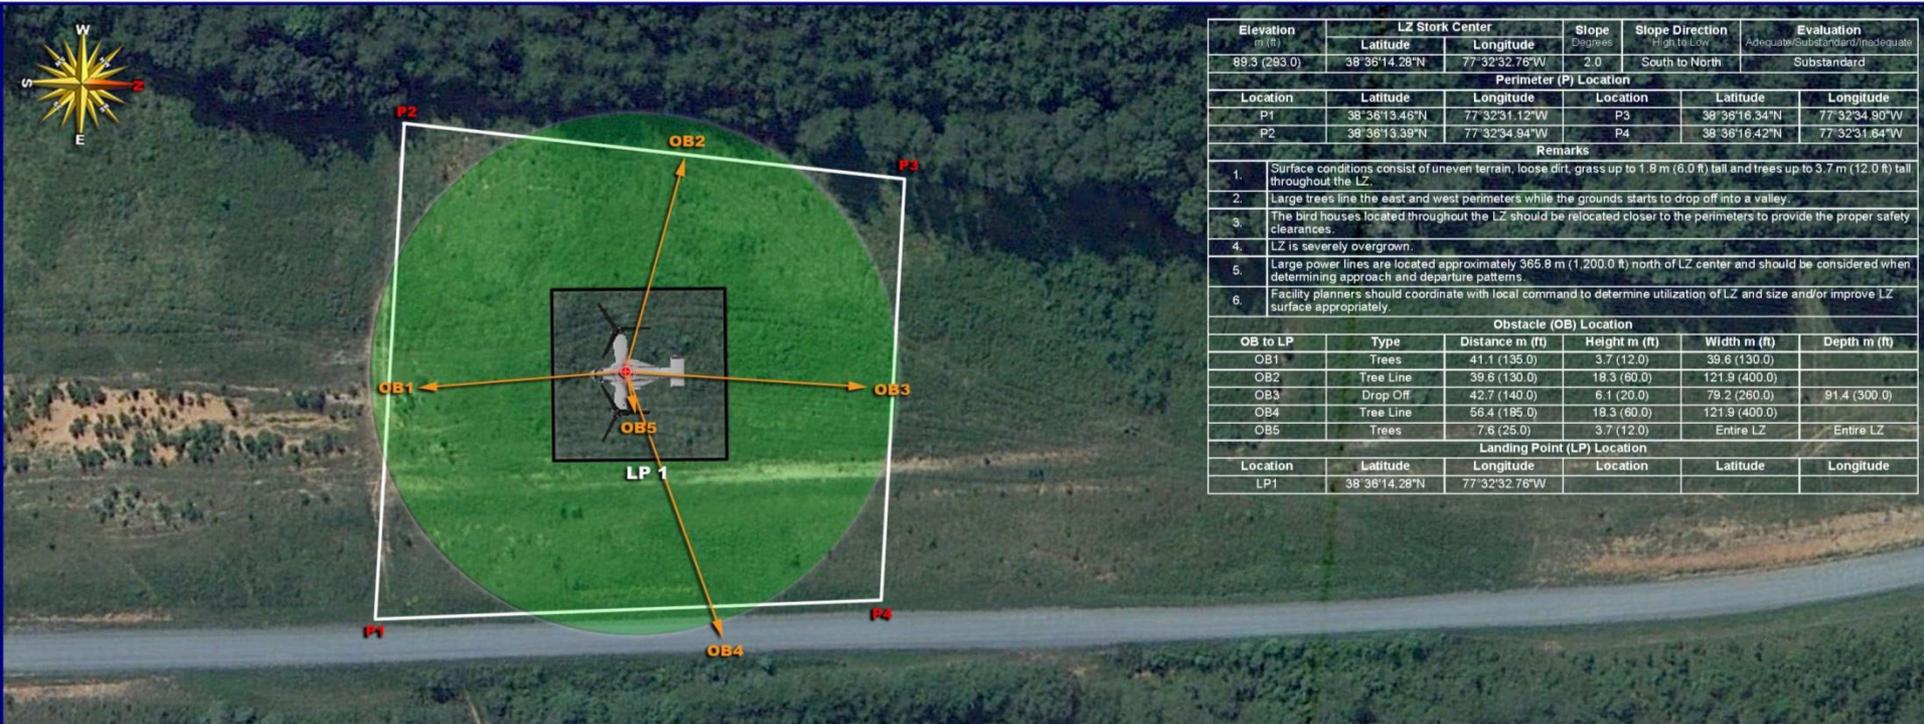
Elevation m (ft)	LZ Stork Center		Slope Degrees	Slope Direction High to Low	Evaluation Adequate/Substandard/Inadequate
	Latitude	Longitude			
89.3 (293.0)	38°36'14.28"N	77°32'32.76"W	2.0	South to North	Substandard
Perimeter (P) Location					
Location	Latitude	Longitude	Location	Latitude	Longitude
P1	38°36'13.46"N	77°32'31.12"W	P3	38°36'16.34"N	77°32'34.90"W
P2	38°36'13.39"N	77°32'34.94"W	P4	38°36'16.42"N	77°32'31.64"W
Remarks

1.	Surface conditions consist of uneven terrain, loose dirt, grass up to 1.8 m (6.0 ft) tall and trees up to 3.7 m (12.0 ft) tall throughout the LZ.

2.	Large trees line the east and west perimeters while the grounds starts to drop off into a valley.				
3.	The bird houses located throughout the LZ should be relocated closer to the perimeters to provide the proper safety clearances.

4.	LZ is severely overgrown.				
5.	Large power lines are located approximately 365.9 m (1,200.0 ft) north of LZ center and should be considered when determining approach and departure patterns.

6.	Facility planners should coordinate with local command to determine utilization of LZ and size and/or improve LZ surface appropriately.				
Obstacle (OB) Location					
OB to LP	Type	Distance m (ft)	Height m (ft)	Width m (ft)	Depth m (ft)
OB1	Trees	41.1 (135.0)	3.7 (12.0)	39.6 (130.0)	
OB2	Tree Line	39.6 (130.0)	18.3 (60.0)	121.9 (400.0)	
OB3	Drop Off	42.7 (140.0)	6.1 (20.0)	79.2 (260.0)	91.4 (300.0)
OB4	Tree Line	56.4 (185.0)	18.3 (60.0)	121.9 (400.0)	
OB5	Trees	7.6 (25.0)	3.7 (12.0)	Entire LZ	Entire LZ
Landing Point (LP) Location					
Location	Latitude	Longitude	Location	Latitude	Longitude
LP1	38°36'14.28"N	77°32'32.76"W
