LZ TURKEY

GRID: 791717

TA: 14B

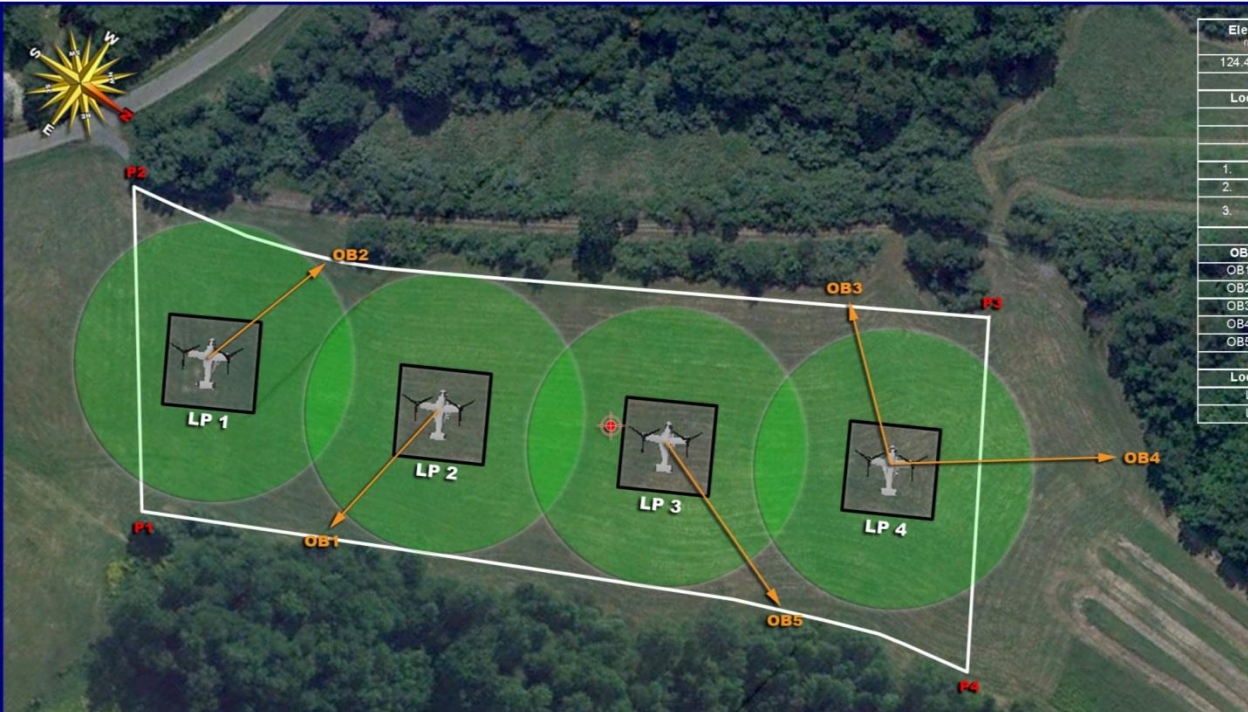
Elevation m (ft)	LZ Turkey Center		Slope Degrees	Slope Direction High to Low	Evaluation Adequate/Substandard/Not Equipped
	Latitude	Longitude			
124.4 (408.0)	38° 33' 51.82" N	77° 32' 15.31" W	2.0	West to East	Substandard
Perimeter (P) Location					
Location	Latitude	Longitude	Location	Latitude	Longitude
P1	38° 33' 48.64" N	77° 32' 9.91" W	P3	38° 33' 53.97" N	77° 32' 20.43" W
P2	38° 33' 46.12" N	77° 32' 13.26" W	P4	38° 33' 56.60" N	77° 32' 16.42" W
Remarks

1. Surface conditions consist of loose dirt and grass up to 1.5 m (5.0 ft) tall throughout the LZ.					
2. Large trees line both the east and west perimeters of the LZ.

3. Facility planners should coordinate with local command to determine utilization of LZ and size and/or improve LZ surface appropriately.					
Obstacle (OB) Location					
OB to LP	Type	Distance m (ft)	Height m (ft)	Width m (ft)	Depth m (ft)
OB1-(LP2)	Tree Line	51.8 (170.0)	18.3 (60.0)	274.3 (900.0)	
OB2-(LP1)	Tree Line	48.8 (160.0)	18.3 (60.0)	274.3 (900.0)	
OB3-(LP4)	Tree Line	54.9 (180.0)	18.3 (60.0)	274.3 (900.0)	
OB4-(LP4)	Tree Line	79.2 (260.0)	18.3 (60.0)	121.9 (400.0)	
OB5-(LP3)	Tree Line	64.0 (210.0)	18.3 (60.0)	274.3 (900.0)	
Landing Point (LP) Location					
Location	Latitude	Longitude	Location	Latitude	Longitude
LP1	38° 33' 48.03" N	77° 32' 12.24" W	LP3	38° 33' 52.27" N	77° 32' 15.89" W
LP2	38° 33' 50.27" N	77° 32' 14.00" W	LP4	38° 33' 54.32" N	77° 32' 17.92" W
