LZ BLACKBIRD

GRID: 775687

TA: 9B

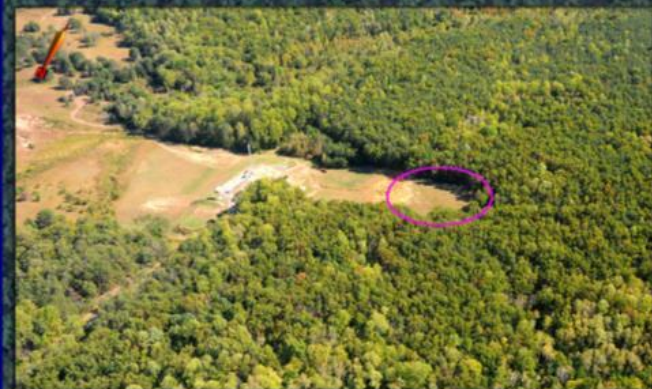
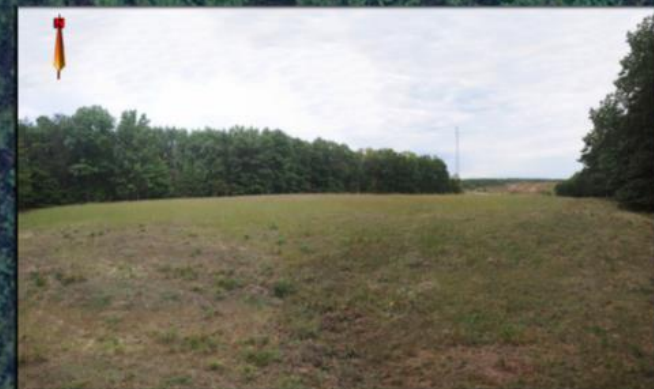
1. Current conditions consist of uneven terrain, loose dirt, gravel, and grass up to 0.9 m (3.0 ft) tall throughout LZ.					
2. LZ sits up on a hill west of a range.

3. Large trees line the north, south, and west perimeter of the LZ.					
4. Evidence of severe water runoff damage exists along the eastern perimeter and is starting to encroach into the LZ perimeter.

5. The five houses located throughout the LZ should be relocated closer to the perimeters to provide the proper safety clearances.					
6. A large radio antenna tower is located approximately 150.9 m (495.0 ft) east of LZ center and should be considered when determining approach and departure patterns.

7. Facility planners should coordinate with local command to determine utilization of LZ and size and/or improve LZ surface appropriately.					
Obstacle (OB) Location					
OB to LP	Type	Distance m (ft)	Height m (ft)	Width m (ft)	Depth m (ft)
OB1	Tree Line	27.4 (90.0)	19.3 (63.0)	99.0 (325.0)	
OB2	Tree Line	29.0 (95.0)	18.3 (60.0)	194.6 (640.0)	
OB3	Radio Tower	154.9 (495.0)	45.7 (150.0)		
OB4	Drop Off	30.6 (100.0)	7.6 (25.0)	67.1 (220.0)	
OB5	Tree Line	27.0 (89.0)	18.3 (60.0)	144.6 (474.0)	
Landing Point (LP) Location					
Location	Latitude	Longitude	Location	Latitude	Longitude
LP1	38° 32' 19.87" N	77° 33' 9.70" W
