# LZ CHICKEN

GRID: 807716

TA: 10A

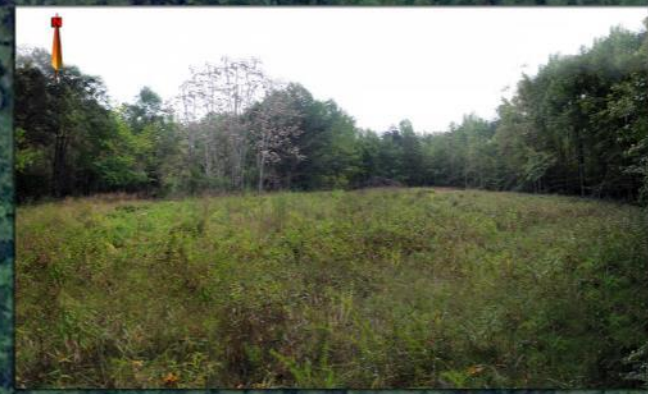
1.	Surface conditions consist of uneven terrain, loose dirt and grass up to 1.8 m (6.0 ft) tall throughout LZ.				
2.	LZ is severely overgrown and has several dead trees and limb that a fallen within the perimeter.

3.	Large trees line the entire perimeter of the LZ.				
4.	Area is not suitable to support MV-22 operations.				
6.	Facility planners should coordinate with local command to determine utilization of LZ and size and/or improve LZ surface appropriately.				
Obstacle (OB) Location					
OB to LP	Type	Distance m (ft)	Height m (ft)	Width m (ft)	Depth m (ft)
OB1	Tree Line	13.7 (450.0)	18.3 (60.0)	76.2 (250.0)	
OB2	Tree Line	36.6 (120.0)	18.3 (60.0)	19.8 (65.0)	
OB3	Tree Line	13.7 (450.0)	18.3 (60.0)	76.2 (250.0)	
OB4	Tree Line	36.6 (120.0)	18.3 (60.0)	24.4 (80.0)	
Landing Point (LP) Location					
Location	Latitude	Longitude	Location	Latitude	Longitude
LP1	38°33'58.70"N	77°31'1.84"W
