# LZ CROW

GRID: 884741

TA: 16G

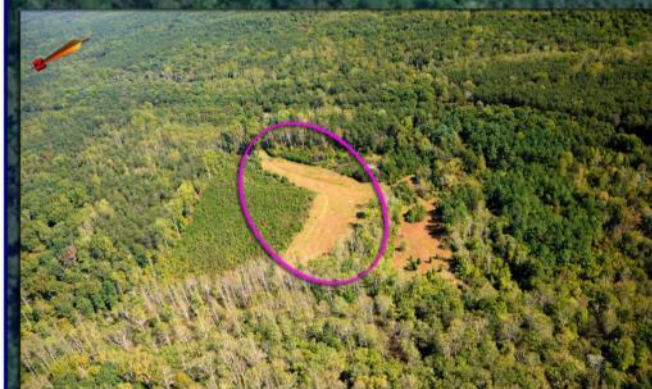
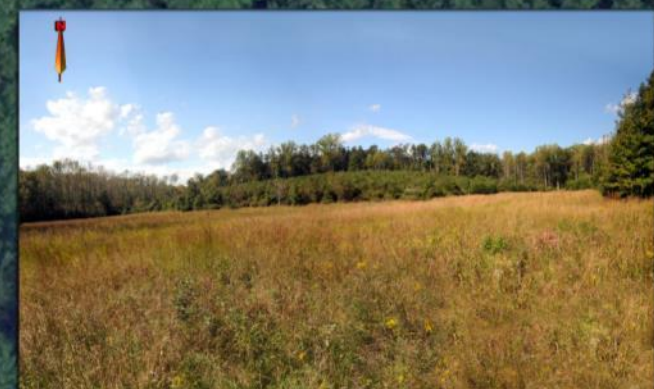
1.	Surface conditions consist of uneven terrain, loose dirt and grass up to 1.2 m (4.0 ft) tall throughout LZ.				
2.	A trench located in the center of the northeast portion of the LZ runs north and south making it inadequate to support MV-22 operations.

3.	The southwest portion of the LZ is prone to flooding during high periods of rain.				
4.	The LZ is surrounded by trees that vary from 7.6 m (25.0 ft) to 18.3 m (60.0 ft) tall.

5.	Facility planners should coordinate with local command to determine utilization of LZ and size and/or improve LZ surface appropriately.				
Obstacle (OB) Location					
OB to LP	Type	Distance m (ft)	Height m (ft)	Width m (ft)	Depth m (ft)
OB1-(LP1)	Tree Line	21.3 (70.0)	7.6 (25.0)	115.8 (380.0)	
OB2-(LP1)	Trench	27.4 (90.0)	0.8 (3.0)	173.7 (570.0)	1.2 (4.0)
OB3-(LP1)	Tree Line	36.8 (120.0)	7.6 (25.0)	137.2 (450.0)	
OB4-(LP1)	Tree Line	36.8 (120.0)	7.6 (25.0)	33.5 (110.0)	
OB5-(LP1)	Tree Line	41.1 (135.0)	18.3 (60.0)	118.9 (390.0)	
OB6-(LP2)	Tree Line	29.0 (95.0)	18.3 (60.0)	118.9 (390.0)	
OB7-(LP2)	Tree Line	29.0 (95.0)	18.3 (60.0)	51.8 (170.0)	
OB8-(LP2)	Tree Line	19.8 (65.0)	7.6 (25.0)	115.8 (380.0)	
Landing Point (LP) Location					
Location	Latitude	Longitude	Location	Latitude	Longitude
LP1	38°35'28.21"N	77°25'42.93"W	LP2	38°35'28.15"N	77°25'46.31"W
