# LZ FINCH

GRID: 864753

TA: 16F

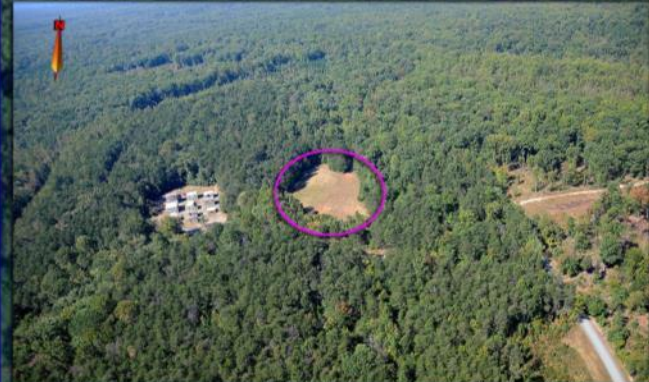
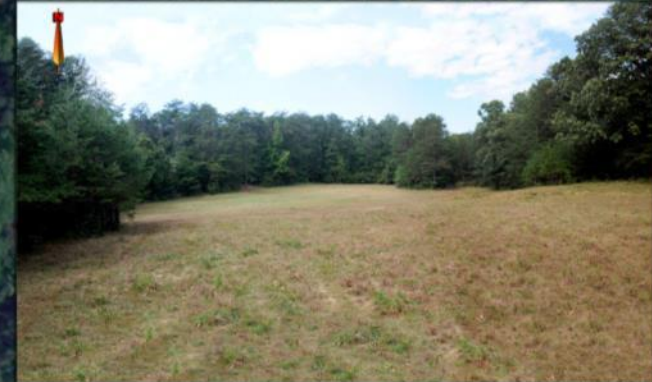
1.	Surface conditions consist of uneven terrain, loose dirt, and grass up to 0.5 m (1.5 ft) tall throughout the LZ.				
2.	The LZ appeared to have just been cleared/moved leaving behind small tree stumps which could puncture the aircraft tires.

3.	The northern portion of the LZ has a slope of 6.0 degrees from the outer perimeter to the center (north to south) while the southern portion of LZ has a slope of 11.0 degrees from the outer perimeter to the center (south to north) causing a bowl like affect in the center of the LZ.

4.	Large trees line the entire perimeter of the LZ.				
6.	Facility planners should coordinate with local command to determine utilization of LZ and size and/or improve LZ surface appropriately.				
Obstacle (OB) Location					
OB to LP	Type	Distance m (ft)	Height m (ft)	Width m (ft)	Depth m (ft)
OB1	Tree Line	30.5 (100.0)	18.3 (60.0)	168.7 (350.0)	
OB2	Elevated Area	25.9 (85.0)	3.0 (10.0)	56.4 (185.0)	
OB3	Tree Line	50.3 (165.0)	18.3 (60.0)	96.0 (315.0)	
OB4	Tree Line	32.0 (105.0)	18.3 (60.0)	99.1 (325.0)	
OB5	Tree Line	24.4 (80.0)	18.3 (60.0)	50.3 (165.0)	
Landing Point (LP) Location					
Location	Latitude	Longitude	Location	Latitude	Longitude
LP1	38°36'1.78"N	77°27'9.94"W
