# LZ MARTIN

GRID: 874766

TA: 16C

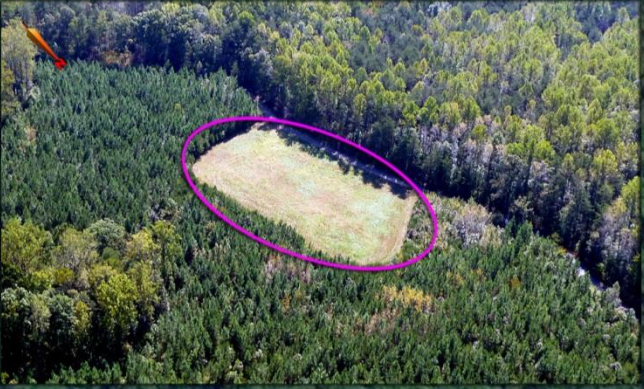
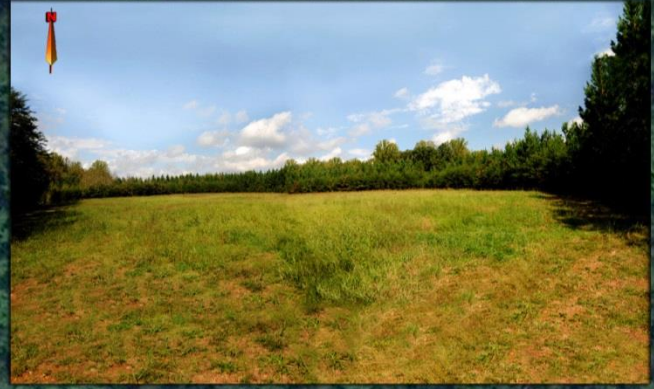
1.	Surface conditions consist of loose dirt and grass up to 0.9 m (3.0 ft) tall throughout the LZ.				
2.	Large trees line the entire perimeter of the LZ.

3.	Facility planners should coordinate with local command to determine utilization of LZ and size and/or improve LZ surface appropriately.				
Obstacle (OB) Location					
OB to LP	Type	Distance m (ft)	Height m (ft)	Width m (ft)	Depth m (ft)
OB1	Tree Line	42.7 (140.0)	7.6 (25.0)	70.1 (230.0)	
OB2	Tree Line	29.0 (95.0)	7.6 (25.0)	84.5 (310.0)	
OB3	Tree Line	45.7 (150.0)	7.6 (25.0)	73.2 (240.0)	
OB4	Tree Line	32.0 (105.0)	18.3 (60.0)	88.4 (290.0)	
Landing Point (LP) Location					
Location	Latitude	Longitude	Location	Latitude	Longitude
LP1	38°36'44.64"N	77°26'28.63"W
