# LZ ORIOLE

GRID: 880730

TA: 12B

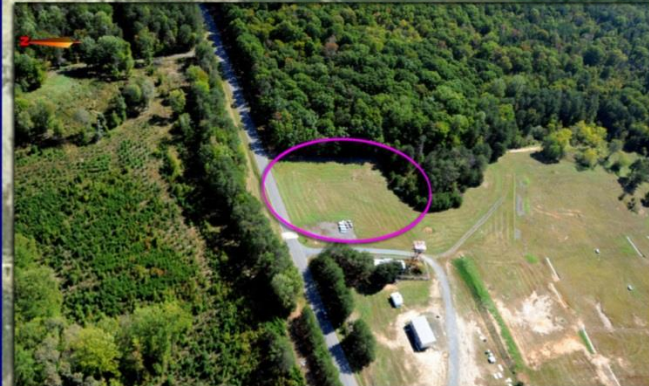
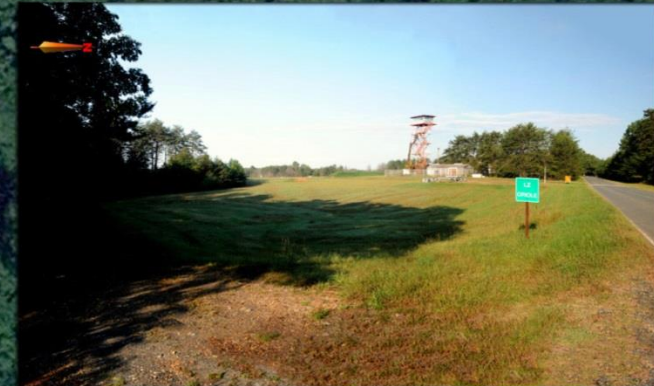
1.	Surface conditions consist of uneven terrain, loose dirt and grass up to 0.6 m (2.0 ft) tall throughout the LZ.				
2.	Large trees line the both the southeast and southwest perimeters.

3.	A large pile of metal construction material is located on the northwest perimeter near the center of the LZ.				
4.	Several holes/ditches located in the southeastern portion of the LZ not allowing the initial 19.8 m (65.0 ft) of the LZ unusable.

5.	The road that runs the length of the northeast perimeter is elevated above the LZ approximately 2.4 m (8.0 ft).				
6.	Facility planners should coordinate with local command to determine utilization of LZ and size and/or improve LZ surface appropriately.				
Obstacle (OB) Location					
OB to LP	Type	Distance m (ft)	Height m (ft)	Width m (ft)	Depth m (ft)
OB1	Range Tower	54.9 (180.0)	18.3 (60.0)	6.1 (20.0)	6.1 (20.0)
OB2	Tree Line	47.5 (155.0)	12.2 (40.0)	45.7 (150.0)	
OB3	Post	32.0 (105.0)	1.8 (6.0)		
OB4	Hill/Road	42.7 (140.0)	2.4 (8.0)	76.2 (250.0)	
OB5	Holes/Ditches	21.3 (70.0)	0.6 (2.0)	88.6 (225.0)	19.8 (65.0)
OB6	Tree Line	42.7 (140.0)	12.2 (40.0)	76.2 (250.0)	
OB7	Tree Line	32.0 (105.0)	18.3 (60.0)	60.3 (195.0)	
Landing Point (LP) Location					
Location	Latitude	Longitude	Location	Latitude	Longitude
LP1	38°34'50.39"N	77°26'1.36"W
