LZ REDBIRD

GRID: 791664

TA: 9B

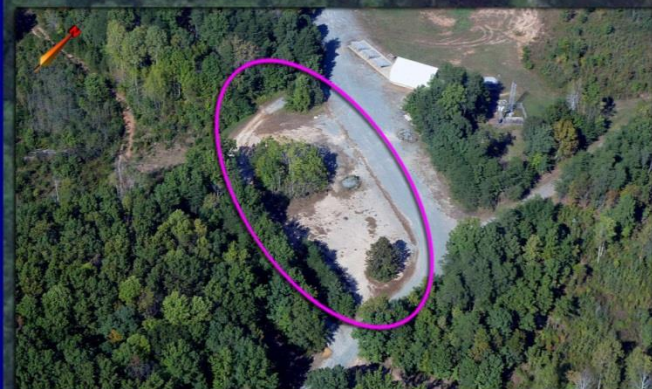
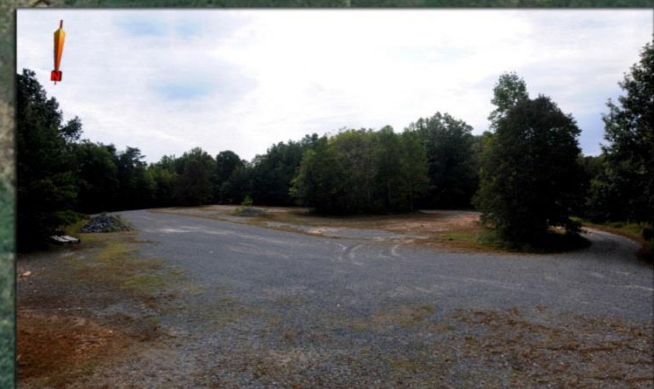
1.	Surface conditions consist of loose dirt, gravel, rocks up to 0.5 m (1.5 ft) in diameter, grass up to 0.3 m (1.0 ft) tall and large trees up to 9.1 m (30.0 ft) tall throughout the LZ.

2.	Large trees line the entire perimeter of the LZ.				
3.	There is a large pile of debris located at the center of the east perimeter of the LZ and should be removed to provide the proper safety clearances.

4.	Facility planners should coordinate with local command to determine utilization of LZ and size and/or improve LZ surface appropriately.				
Obstacle (OB) Location					
OB to LP	Type	Distance m (ft)	Height m (ft)	Width m (ft)	Depth m (ft)
OB1	Tree Line	30.5 (100.0)	18.3 (60.0)	71.6 (235.0)	
OB2	Tree	12.2 (40.0)	9.1 (30.0)	9.1 (30.0)	9.1 (30.0)
OB3	Tree Line	19.8 (65.0)	9.1 (30.0)	35.1 (115.0)	6.1 (20.0)
OB4	Tree Line	22.9 (75.0)	18.3 (60.0)	82.3 (270.0)	
OB5	Tree	18.3 (60.0)	9.1 (30.0)	18.3 (60.0)	16.8 (55.0)
OB6	Tree	62.5 (205.0)	9.1 (30.0)	16.8 (55.0)	6.1 (20.0)
OB7	Pile of Debris	21.3 (70.0)	1.2 (4.0)	6.1 (20.0)	6.1 (20.0)
OB8	Tree Line	36.6 (120.0)	18.3 (60.0)	54.9 (180.0)	
Landing Point (LP) Location					
Location	Latitude	Longitude	Location	Latitude	Longitude
LP1	38°31'5.67"N	77°32'3.69"W
