# LZ SNIPE

GRID: 830764

TA: 16D

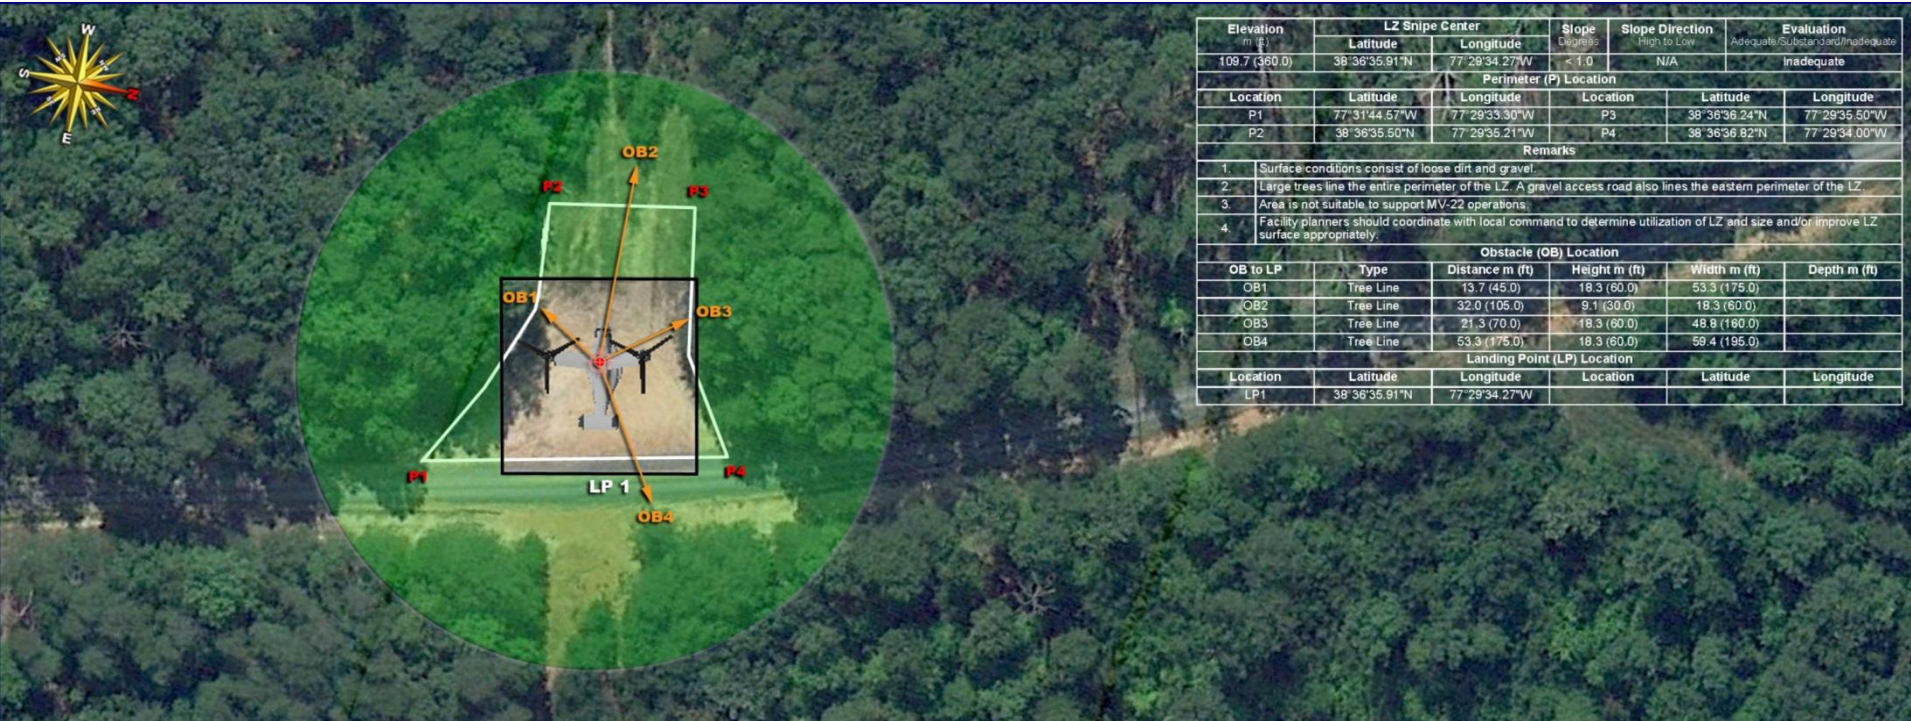
1. Surface conditions consist of loose dirt and gravel.					
2. Large trees line the entire perimeter of the LZ. A gravel access road also lines the eastern perimeter of the LZ.

3. Area is not suitable to support MV-22 operations.					
4. Facility planners should coordinate with local command to determine utilization of LZ and size and/or improve LZ surface appropriately.					
Obstacle (OB) Location					
OB to LP	Type	Distance m (ft)	Height m (ft)	Width m (ft)	Depth m (ft)
OB1	Tree Line	13.7 (45.0)	18.3 (60.0)	53.3 (175.0)	
OB2	Tree Line	32.0 (105.0)	9.1 (30.0)	18.3 (60.0)	
OB3	Tree Line	21.3 (70.0)	18.3 (60.0)	48.8 (160.0)	
OB4	Tree Line	53.3 (175.0)	18.3 (60.0)	59.4 (195.0)	
Landing Point (LP) Location					
Location	Latitude	Longitude	Location	Latitude	Longitude
LP1	38° 36' 35.91" N	77° 29' 34.27" W
