LZ SPARROW

GRID: 862751

TA: 16F

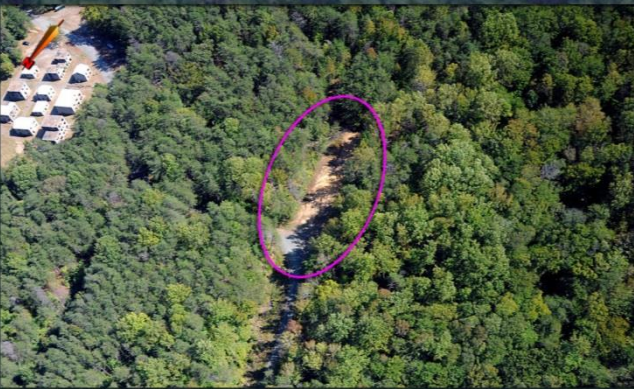
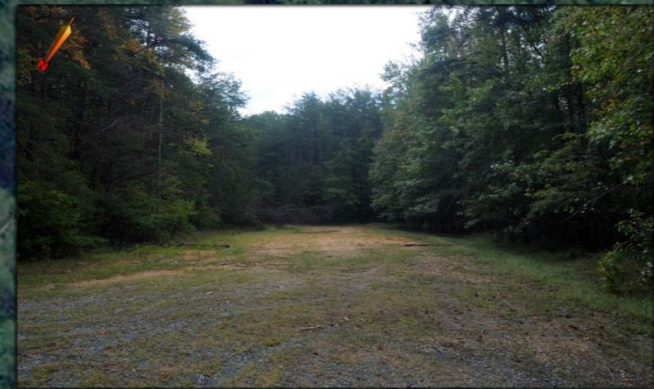
1.	Surface conditions consist of loose dirt, gravel and grass up to 0.3 m (1.0 ft) tall throughout the LZ.				
2.	Several dead trees and limbs have fallen within the perimeter.

3.	Area is not suitable to support MV-22 operations.				
4.	Facility planners should coordinate with local command to determine utilization of LZ and size and/or improve LZ surface appropriately.				
Obstacle (OB) Location					
OB to LP	Type	Distance m (ft)	Height m (ft)	Width m (ft)	Depth m (ft)
OB1	Tree Line	30.5 (100.0)	18.3 (60.0)	15.2 (50.0)	
OB2	Tree Line	7.6 (25.0)	18.3 (60.0)	73.2 (240.0)	
OB3	Tree Line	7.6 (25.0)	18.3 (60.0)	73.2 (240.0)	
Landing Point (LP) Location					
Location	Latitude	Longitude	Location	Latitude	Longitude
LP1	38° 35'55.29"N	77° 27'18.94"W
