# LZ TERN

GRID: 810759

TA: 15B

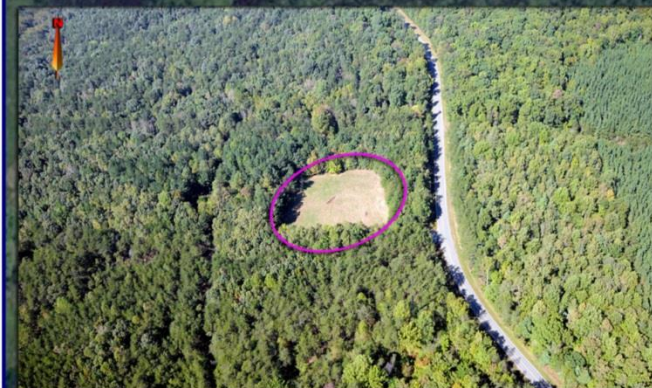
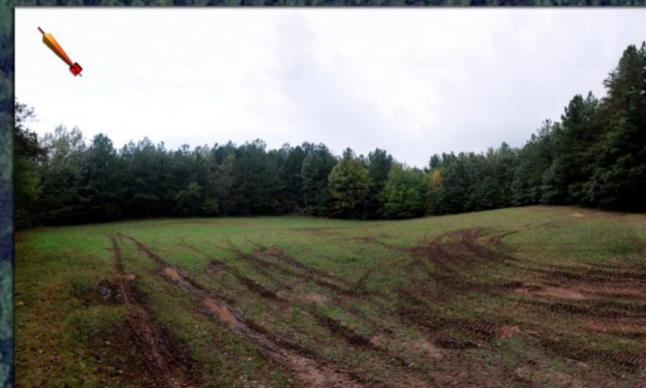
1.	Surface conditions consist of loose dirt and grass up to 0.3 m (1.0 ft) tall throughout the LZ.				
2.	The LZ slope < 2.0 degrees from center in all directions creating a bowl like affect in the center of the LZ causing potential flooding during periods of heavy rain.

3.	Large tree line the entire perimeter of the LZ.				
4.	Facility planners should coordinate with local command to determine utilization of LZ and size and/or improve LZ surface appropriately.				
Obstacle (OB) Location					
OB to LP	Type	Distance m (ft)	Height m (ft)	Width m (ft)	Depth m (ft)
OB1	Tree Line	32.0 (105.0)	18.3 (60.0)	68.6 (225.0)	
OB2	Tree Line	29.0 (95.0)	18.3 (60.0)	73.2 (240.0)	
OB3	Tree Line	32.0 (105.0)	18.3 (60.0)	57.9 (190.0)	
OB4	Tree Line	32.0 (105.0)	18.3 (60.0)	54.9 (180.0)	
Landing Point (LP) Location					
Location	Latitude	Longitude	Location	Latitude	Longitude
LP1	38° 36' 17.34" N	77° 30' 53.16" W
