# LZ BUZZARD

GRID: 806727

TA: 15A

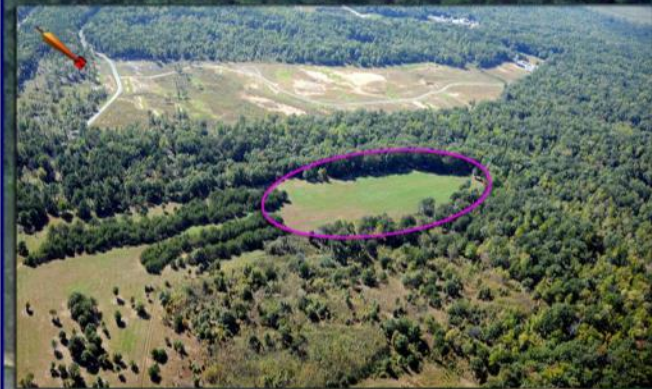
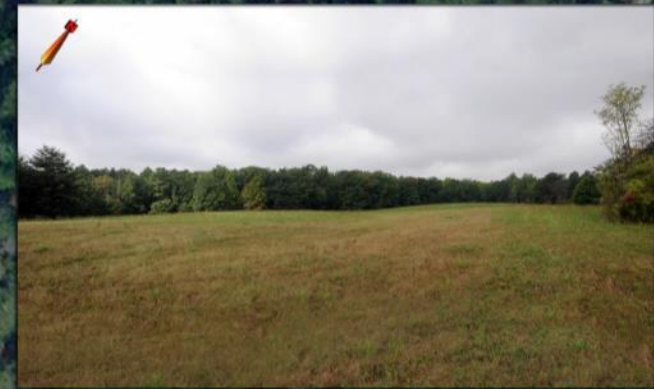
+ CENTER MARK  
 ROTOR DOWNWASH  
 100' X 100' PAD  
 OBSTACLES  
 PERIMETER  
 PERIMETER POINTS
