LZ DUCK

GRID: 821745

TA: 15B

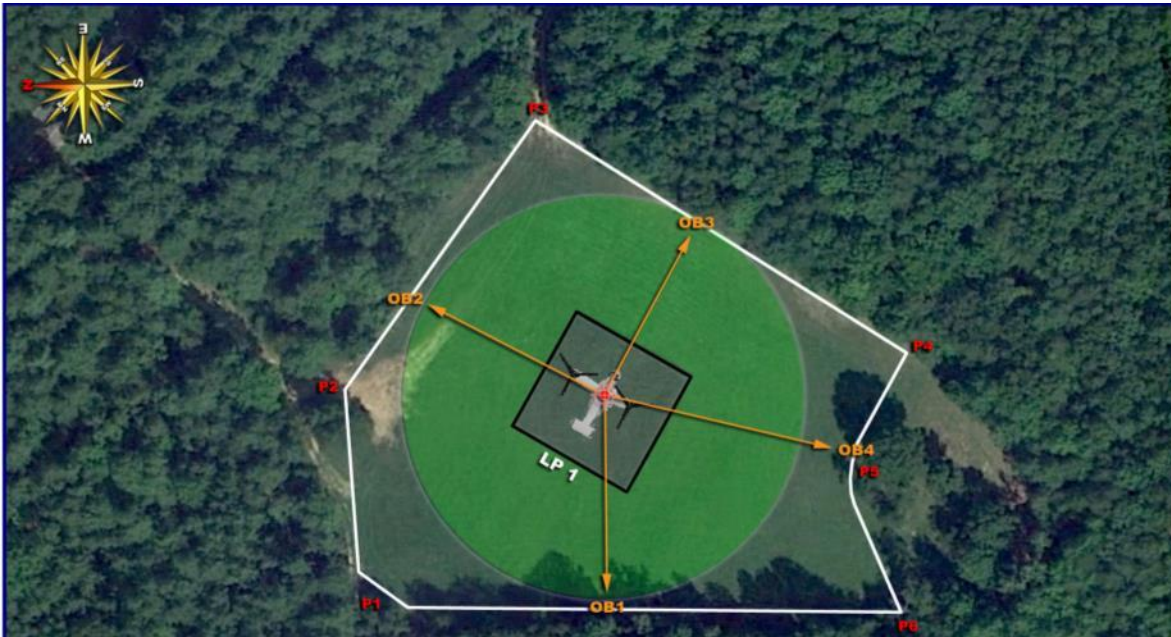
Elevation m (ft)	LZ Duck Center		Slope Degrees	Slope Direction High to Low	Evaluation Adequate/Substandard/Inadequate
	Latitude	Longitude			
113.1 (371.0)	38°35'32.47"N	77°30'9.29"W	3.5	East to West	Substandard
Perimeter (P) Location					
Location	Latitude	Longitude	Location	Latitude	Longitude
P1	38°35'34.29"N	77°30'9.55"W	P4	38°35'29.89"N	77°30'7.72"W
P2	38°35'34.29"N	77°30'7.70"W	P5	38°35'30.36"N	77°30'8.71"W
P3	38°35'32.84"N	77°30'5.13"W	P6	38°35'30.10"N	77°30'10.30"W
Remarks

1.	Surface conditions consist of uneven terrain, loose dirt and grass up to 0.9 m (3.0 ft) tall throughout the LZ.				
2.	Large trees line the entire perimeter of the LZ.

3.	Facility planners should coordinate with local command to determine utilization of LZ and size and/or improve LZ surface appropriately.				
Obstacle (OB) Location					
OB to LP	Type	Distance m (ft)	Height m (ft)	Width m (ft)	Depth m (ft)
OB1	Tree Line	45.7 (150.0)	18.3 (60.0)	56.4 (385.0)	
OB2	Tree Line	53.3 (175.0)	18.3 (60.0)	121.9 (400.0)	
OB3	Tree Line	45.7 (150.0)	18.3 (60.0)	109.7 (360.0)	
OB4	Tree Line	56.4 (185.0)	18.3 (60.0)	73.2 (240.0)	
Landing Point (LP) Location					
Location	Latitude	Longitude	Location	Latitude	Longitude
LP1	38°35'32.47"N	77°30'9.29"W
