LZ FALCON

GRID: 907676

TA: 6B

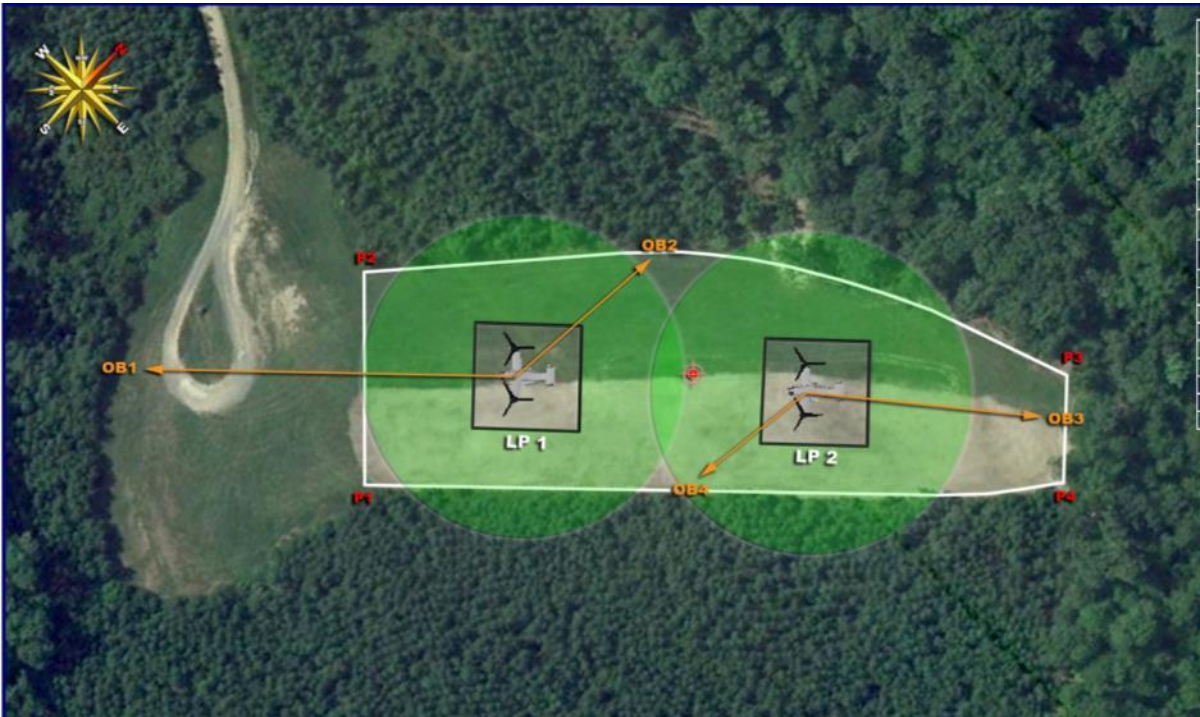
Elevation m (ft)	LZ Falcon Center		Slope Degrees	Slope Direction High to Low	Evaluation Adequate/Substandard/Inadequate
	Latitude	Longitude			
79.2 (260.0)	38° 31' 57.93"N	77° 23' 59.34"W	3.0	South to North	Substandard
Perimeter (P) Location					
Location	Latitude	Longitude	Location	Latitude	Longitude
P1	38° 31' 54.61"N	77° 24' 1.79"W	P3	38° 32' 0.08"N	77° 23' 56.53"W
P2	38° 31' 56.13"N	77° 24' 3.64"W	P4	38° 31' 59.27"N	77° 23' 56.61"W
Remarks

1.	Surface conditions consist of loose dirt, gravel and grass up to 0.2 m (0.5 ft) tall throughout the LZ.				
2.	The eastern perimeter is lined with 6.1 m (20.0 ft) tall trees while the north, south and western perimeters are lined with 18.3 m (60.0 ft) tall trees.

3.	A large water tower is located approximately 1127.8 m (3,700.0 ft) southwest of LZ center and should be considered when determining approach and departure patterns.

4.	Facility planners should coordinate with local command to determine utilization of LZ and size and/or improve LZ surface appropriately.				
Obstacle (OB) Location					
OB to LP	Type	Distance m (ft)	Height m (ft)	Width m (ft)	Depth m (ft)
OB1-(LP1)	Tree Line	125.0 (410.0)	18.3 (60.0)	103.6 (340.0)	
OB2-(LP1)	Tree Line	48.8 (160.0)	19.3 (60.0)	198.1 (650.0)	
OB3-(LP2)	Tree Line	76.2 (250.0)	19.3 (60.0)	54.9 (180.0)	
OB4-(LP2)	Tree Line	39.6 (130.0)	6.1 (20.0)	207.3 (680.0)	
Landing Point (LP) Location					
Location	Latitude	Longitude	Location	Latitude	Longitude
LP1	38° 31' 56.36"N	77° 24' 1.41"W	LP2	38° 31' 58.14"N	77° 23' 58.72"W
