LZ PEACOCK

GRID: 874775

TA: 16G

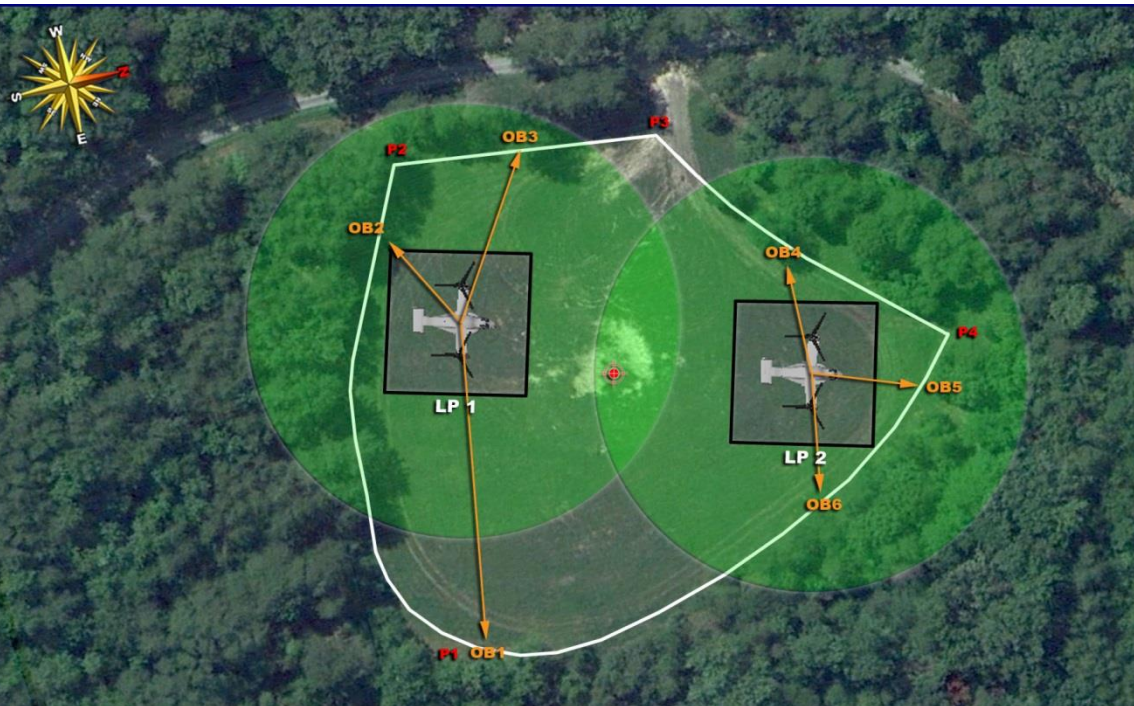
1.	Surface conditions consist of uneven terrain, loose dirt, gravel and grass up to 0.9 m (3.0 ft) tall throughout the LZ.				
2.	Large trees line the entire perimeter of the LZ.

3.	Large power lines are located approximately 426.7 m (1,400.0 ft) north of LZ center and a large radio antenna used for a Public Broadcasting Corporation is also located approximately 914.4 m (3,000.0 ft) north of LZ center. Both obstacles should be considered when determining approach and departure patterns.

4.	Facility planners should coordinate with local command to determine utilization of LZ and size and/or improve LZ surface appropriately.				
Obstacle (OB) Location					
OB to LP	Type	Distance m (ft)	Height m (ft)	Width m (ft)	Depth m (ft)
OB1-(LP1)	Tree Line	70.1 (230.0)	18.3 (60.0)	85.3 (280.0)	
OB2-(LP1)	Tree Line	24.4 (80.0)	18.3 (60.0)	91.4 (300.0)	
OB3-(LP1)	Tree Line	41.1 (135.0)	18.3 (60.0)	61.0 (200.0)	
OB4-(LP2)	Tree Line	21.3 (70.0)	18.3 (60.0)	80.8 (265.0)	
OB5-(LP2)	Tree Line	22.9 (75.0)	18.3 (60.0)	30.5 (100.0)	
OB6-(LP2)	Tree Line	27.4 (90.0)	18.3 (60.0)	70.1 (230.0)	
Landing Point (LP) Location					
Location	Latitude	Longitude	Location	Latitude	Longitude
LP1	38°37'13.43"N	77°26'32.80"W	LP2	38°37'15.74"N	77°26'31.47"W
