LZ PEREGRINE

GRID: 856747

TA: 16E

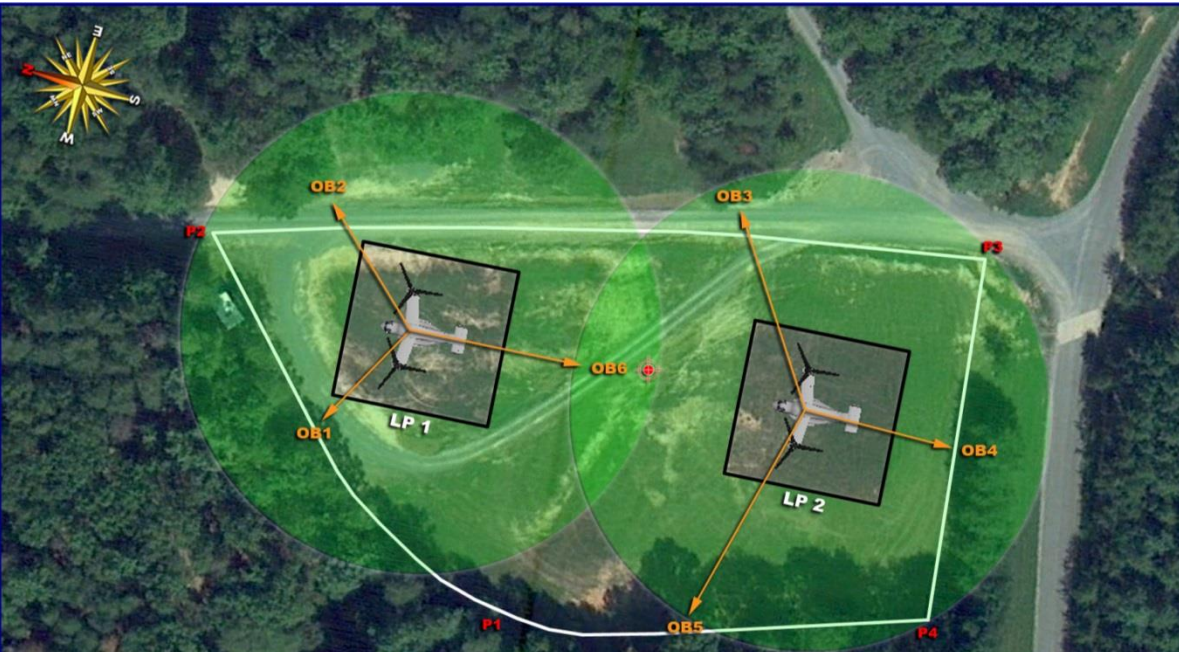
Elevation m (ft)	LZ Peregrine Center		Slope Degrees	Slope Direction High to Low	Evaluation Adequate/Gravel and/or Inadequate
	Latitude	Longitude			
112.8 (370.0)	38°35'40.89"N	77°27'41.71"W	< 1.0	N/A	Substandard
Perimeter (P) Location					
Location	Latitude	Longitude	Location	Latitude	Longitude
P1	38°35'41.89"N	77°27'44.13"W	P3	38°35'39.28"N	77°27'40.49"W
P2	38°35'44.20"N	77°27'41.54"W	P4	38°35'39.18"N	77°27'43.49"W
Remarks

1.	Surface conditions consist of loose dirt, gravel and grass up to 0.2 m (0.5 ft) tall throughout the LZ.				
2.	Large trees line the enter perimeter of the LZ.

3.	A small gravel road runs through the center of the LZ.				
4.	Facility planners should coordinate with local command to determine utilization of LZ and size and/or improve LZ surface appropriately.				
Obstacle (OB) Location					
OB to LP	Type	Distance m (ft)	Height m (ft)	Width m (ft)	Depth m (ft)
OB1-(LP1)	Tree Line	25.9 (85.0)	18.3 (60.0)	91.4 (300.0)	
OB2-(LP1)	Tree Line	27.4 (90.0)	18.3 (60.0)	170.7 (560.0)	
OB3-(LP2)	Tree Line	41.1 (135.0)	18.3 (60.0)	109.7 (360.0)	
OB4-(LP2)	Tree Line	27.4 (90.0)	18.3 (60.0)	48.8 (160.0)	
OB5-(LP2)	Tree Line	45.7 (150.0)	18.3 (60.0)	91.4 (300.0)	
OB6-(LP1)	Gravel Road	35.1 (115.0)		91.4 (300.0)	3.7 (12.0)
Landing Point (LP) Location					
Location	Latitude	Longitude	Location	Latitude	Longitude
LP1	38°35'42.79"N	77°27'41.98"W	LP2	38°35'40.20"N	77°27'41.98"W

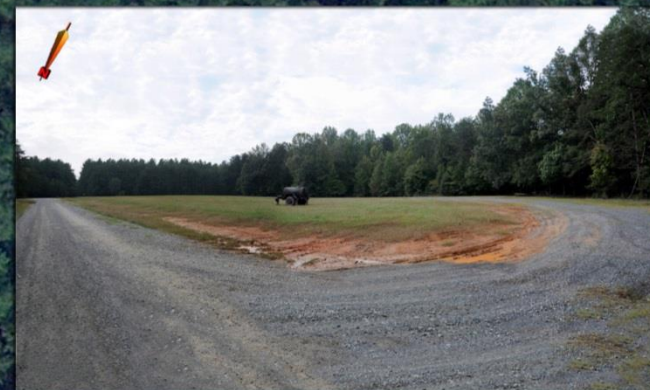
+ CENTER MARK
 ROTOR DOWNWASH
 100' X 100' PAD
 OBSTACLES
 PERIMETER
 PERIMETER POINTS
