LZ WOODPECKER

GRID: 856737

TA: 11A

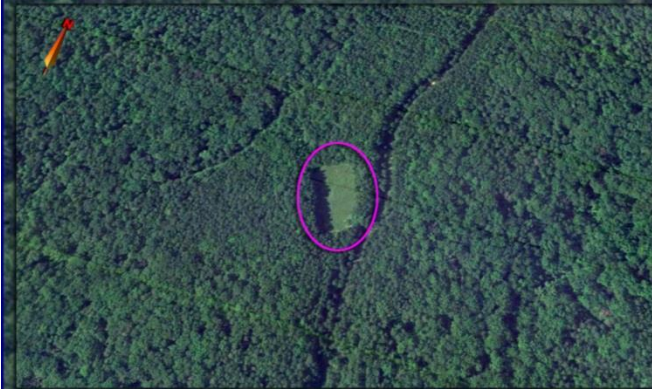
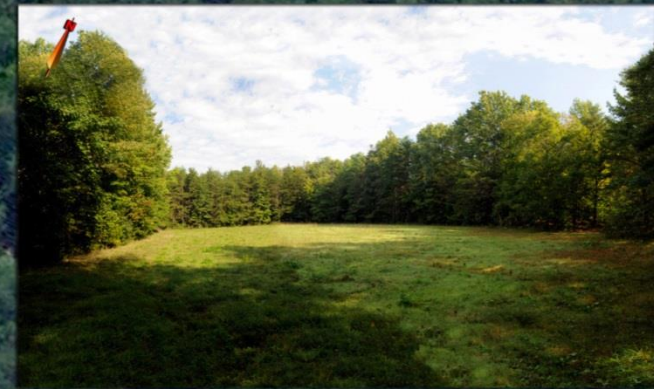
Elevation m (ft)	LZ Woodpecker Center		Slope Degrees	Slope Direction High to Low	Evaluation Adequate/Substandard/Inadequate
	Latitude	Longitude			
91.1 (299.0)	38°35'10.13"N	77°27'40.81"W	2.0	East to West	Substandard
Perimeter (P) Location					
Location	Latitude	Longitude	Location	Latitude	Longitude
P1	38°35'9.00"N	77°27'39.92"W	P4	38°35'11.33"N	77°27'40.67"W
P2	38°35'8.62"N	77°27'40.73"W	P5	38°35'9.96"N	77°27'39.76"W
P3	38°35'10.84"N	77°27'42.13"W			
Remarks

1.	Surface conditions consist of loose dirt and grass up to 1.0 m (3.0 ft) tall throughout the LZ.				
2.	Large trees line the entire perimeter of the LZ.

3.	Facility planners should coordinate with local command to determine utilization of LZ and size and/or improve LZ surface appropriately.				
Obstacle (OB) Location					
OB to LP	Type	Distance m (ft)	Height m (ft)	Width m (ft)	Depth m (ft)
OB1	Tree Line	32.0 (105.0)	18.3 (60.0)	30.5 (100.0)	
OB2	Tree Line	18.3 (60.0)	18.3 (60.0)	73.2 (240.0)	
OB3	Tree Line	30.5 (100.0)	18.3 (60.0)	36.8 (120.0)	
OB4	Tree Line	16.8 (55.0)	18.3 (60.0)	48.8 (160.0)	
Landing Point (LP) Location					
Location	Latitude	Longitude	Location	Latitude	Longitude
LP1	38°35'10.13"N	77°27'40.81"W
