# 2022-2023 MS4 ANNUAL REPORT FOR MARINE CORPS INSTALLATIONS NATIONAL CAPITAL REGION - MARINE CORPS BASE QUANTICO (MCINCR-MCBQ)

MARINE CORPS INSTALLATIONS NATIONAL CAPITAL REGION - MARINE CORPS BASE QUANTICO MS4 ANNUAL REPORT

## JULY 2022-JUNE 2023

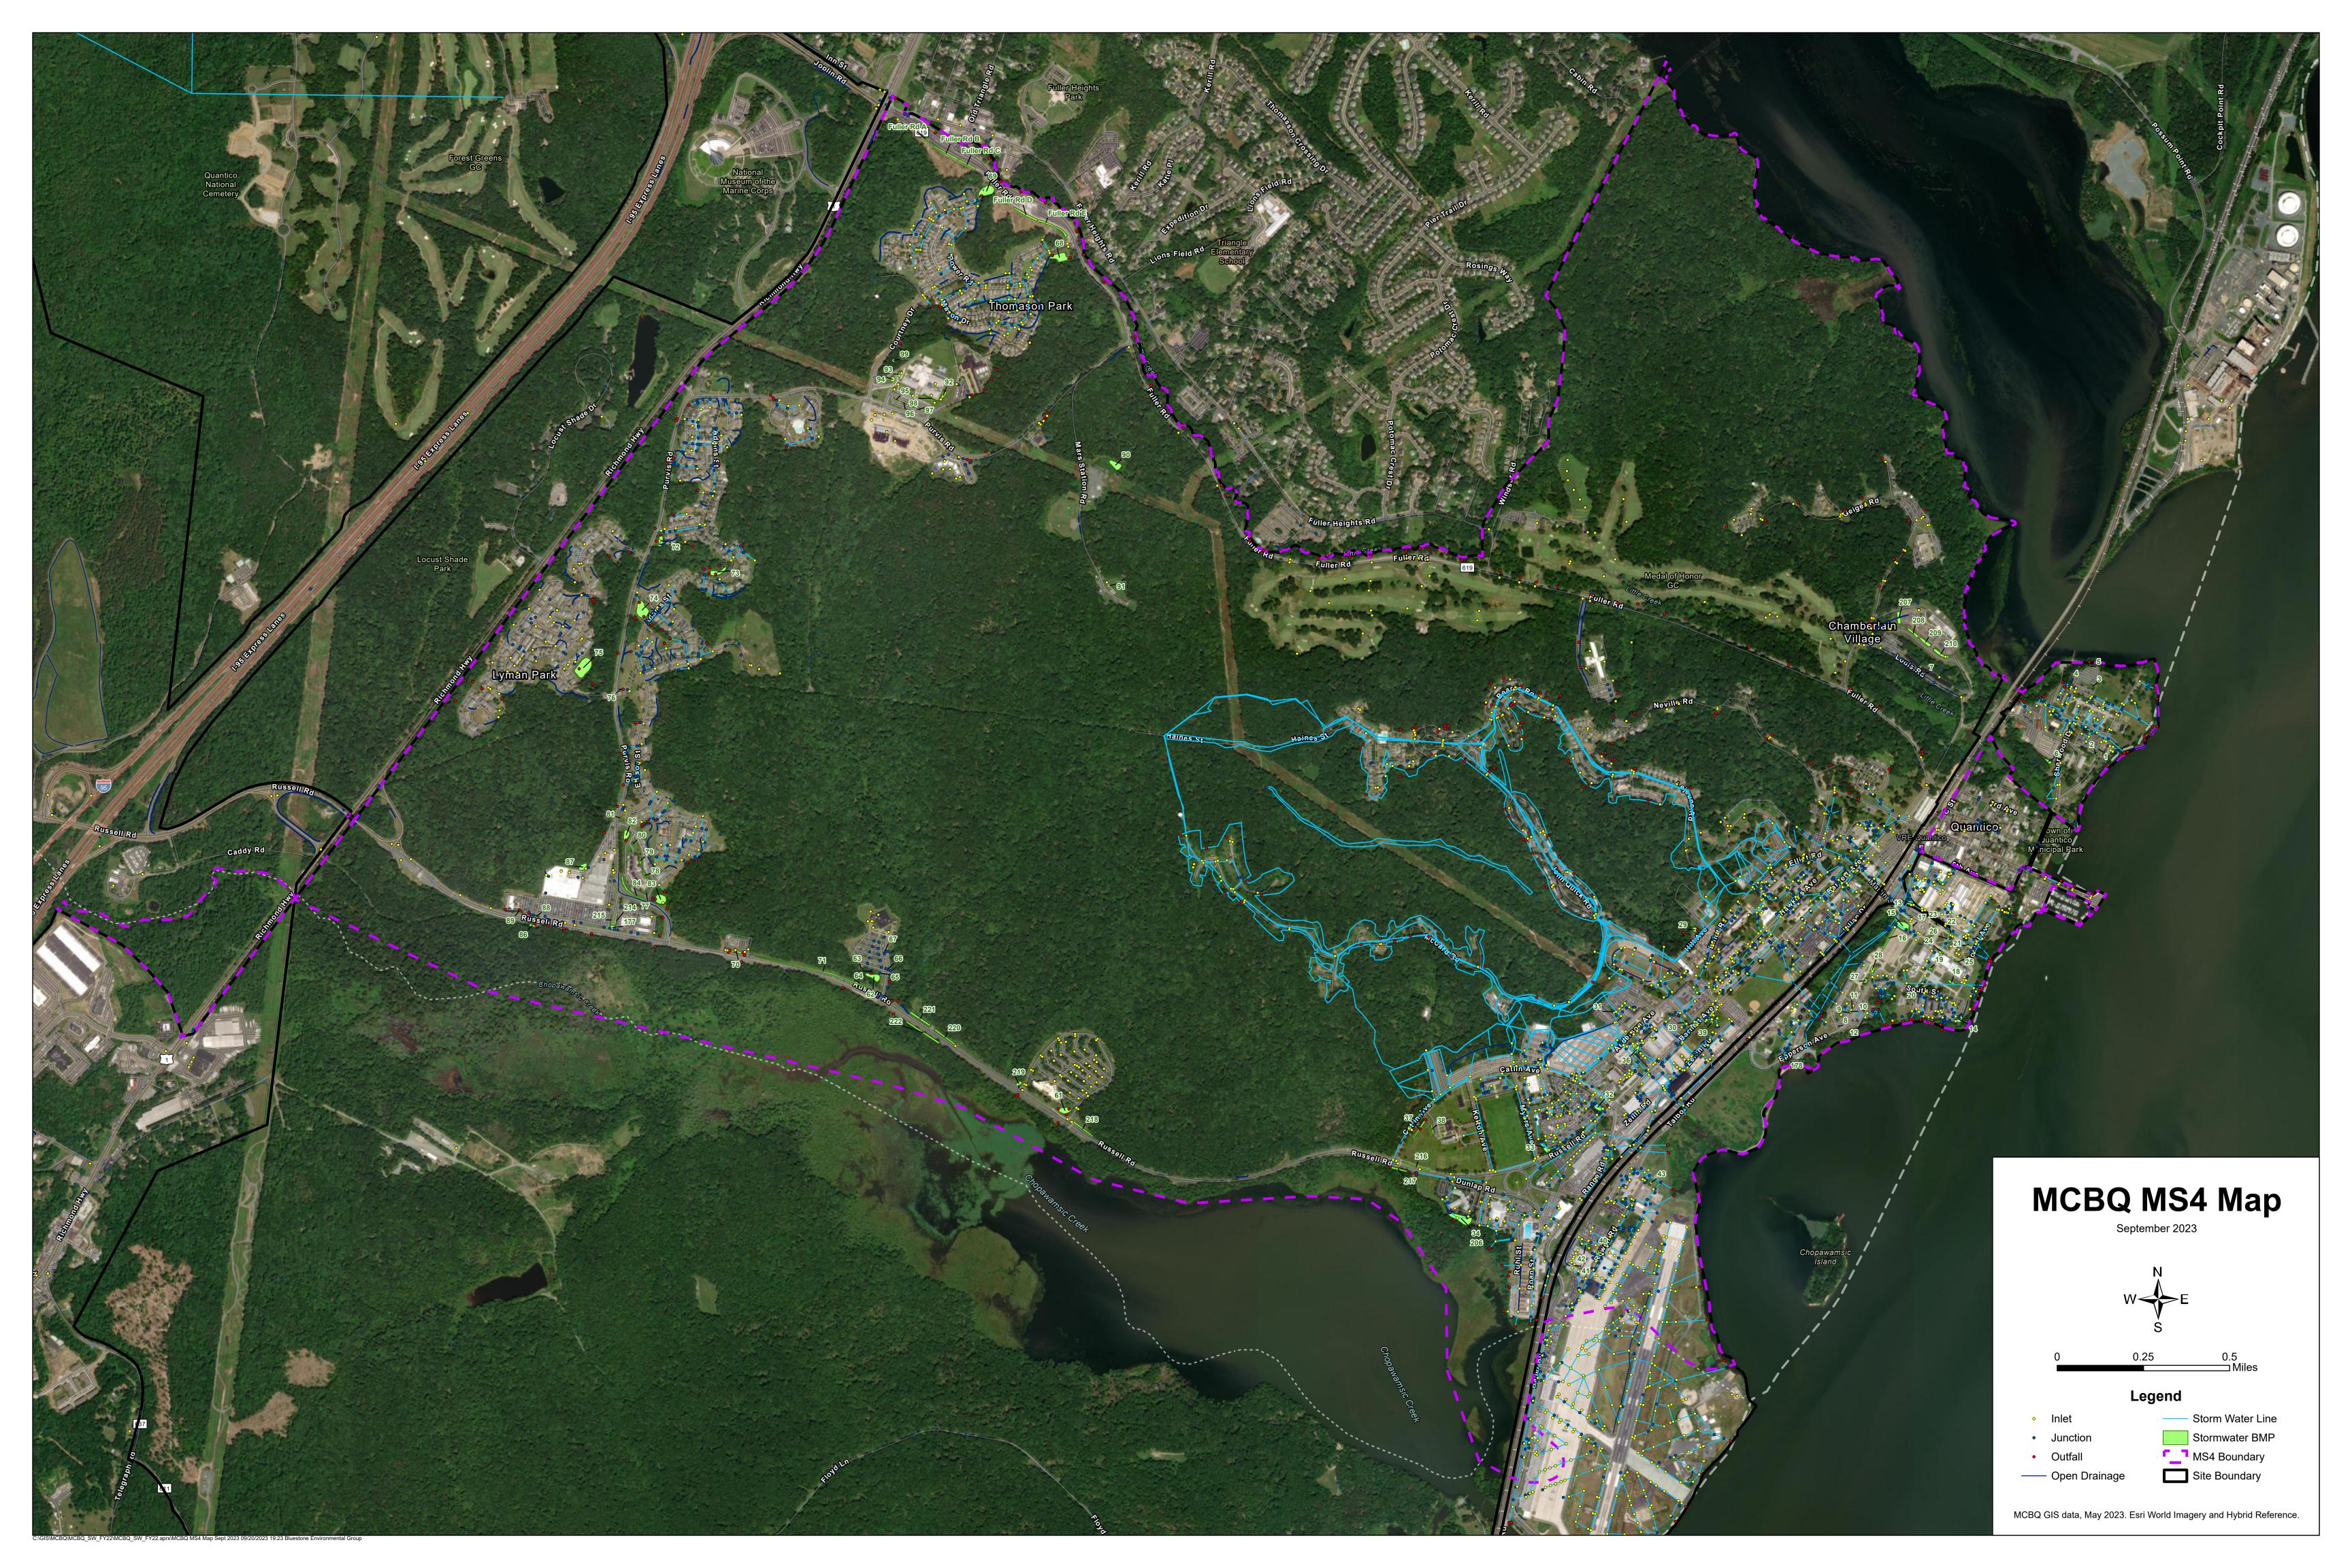
Appendix B MS4 Map

The MS4 map and information table were submitted to VDEQ prior to the 1 July 2019 date listed in Part I.E.3.a.(2) of the MS4 permit. In accordance with Part I.E.3.a.3, updates to the MS4 map and information table were made by October 1 of each year. Part I.E.3.e(1) requires confirmation of these updates. MCINCR-MCBQ confirms that the MS4 map and information table were updated to reflect changes to the MS4 occurring on or before 30 June 2022. **Appendix A** provides an updated version of the information table and **Appendix B** provides an updated version of the MS4 map.
